**A Tree Survey and Plan of Preservation,  
For,  
Suir Island,  
Clonmel,  
Co. Tipperary.**

**KENNETH HENNESSY ARCHITECTS LTD**

**Prepared by, (Arbor-Care Ltd)**

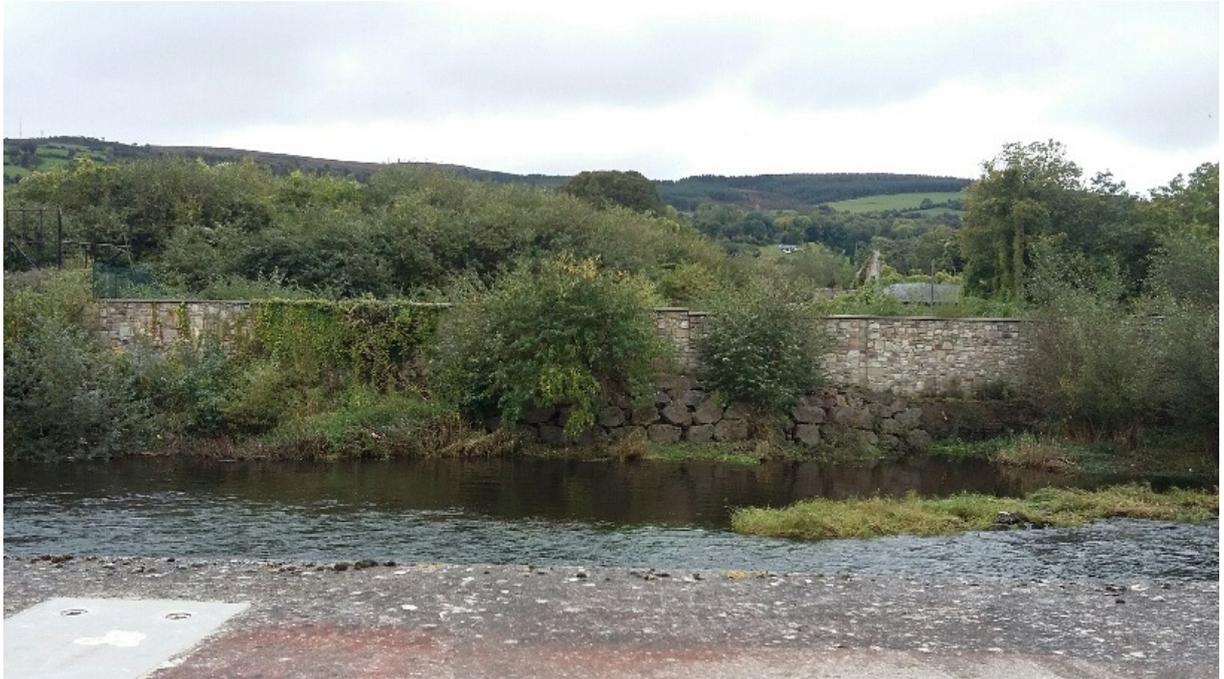
**Figure 1.**  
**Below highlights a suitable area for the footbridge. There would be no impact on the trees.**

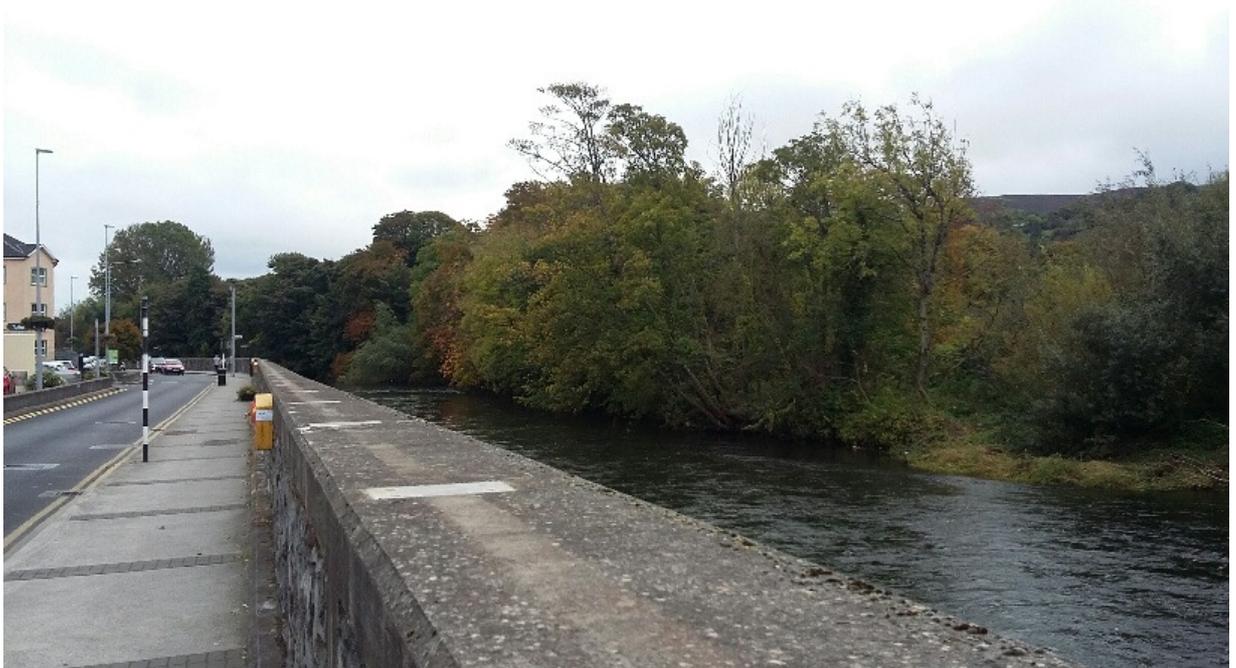
**Figure 2. Displays the trees along the spit. Due to their location they could not be safely tagged. However they are of high amenity value and in good condition**

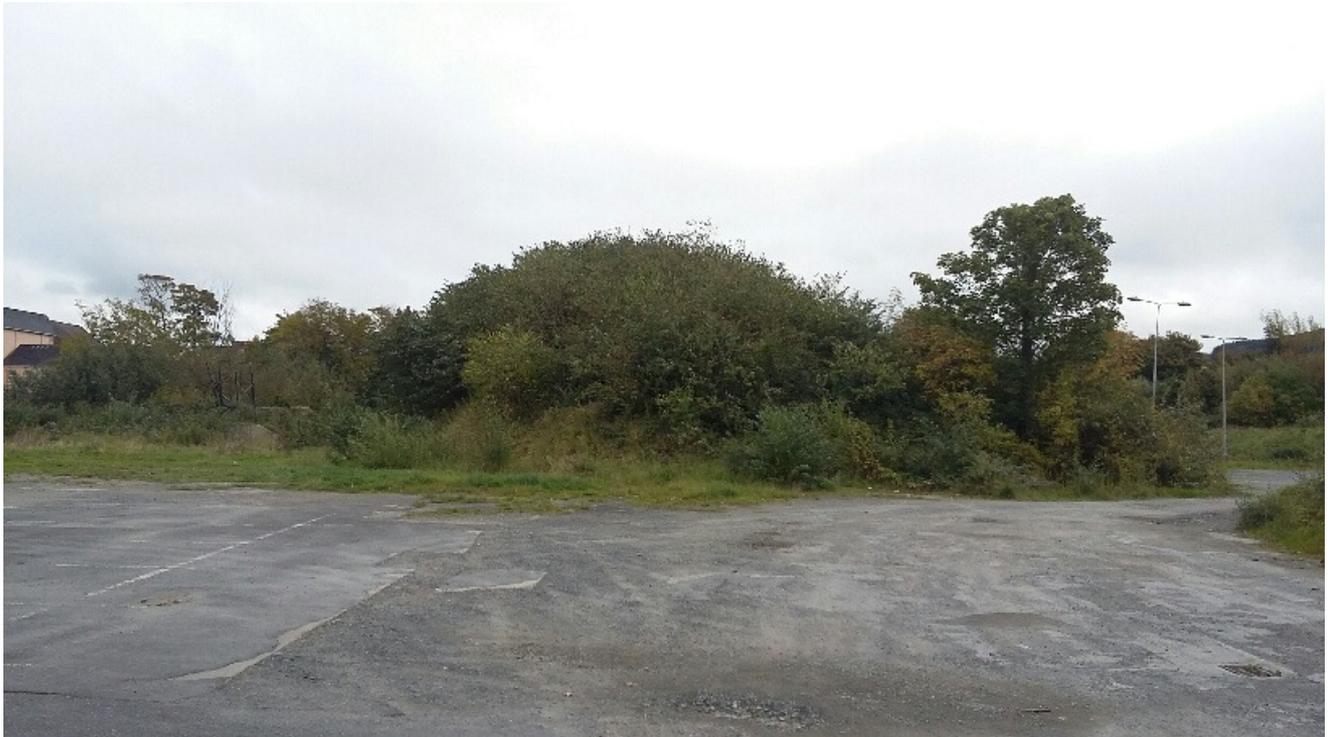
**Figure 3. Displays the soil heap that is over grown.**

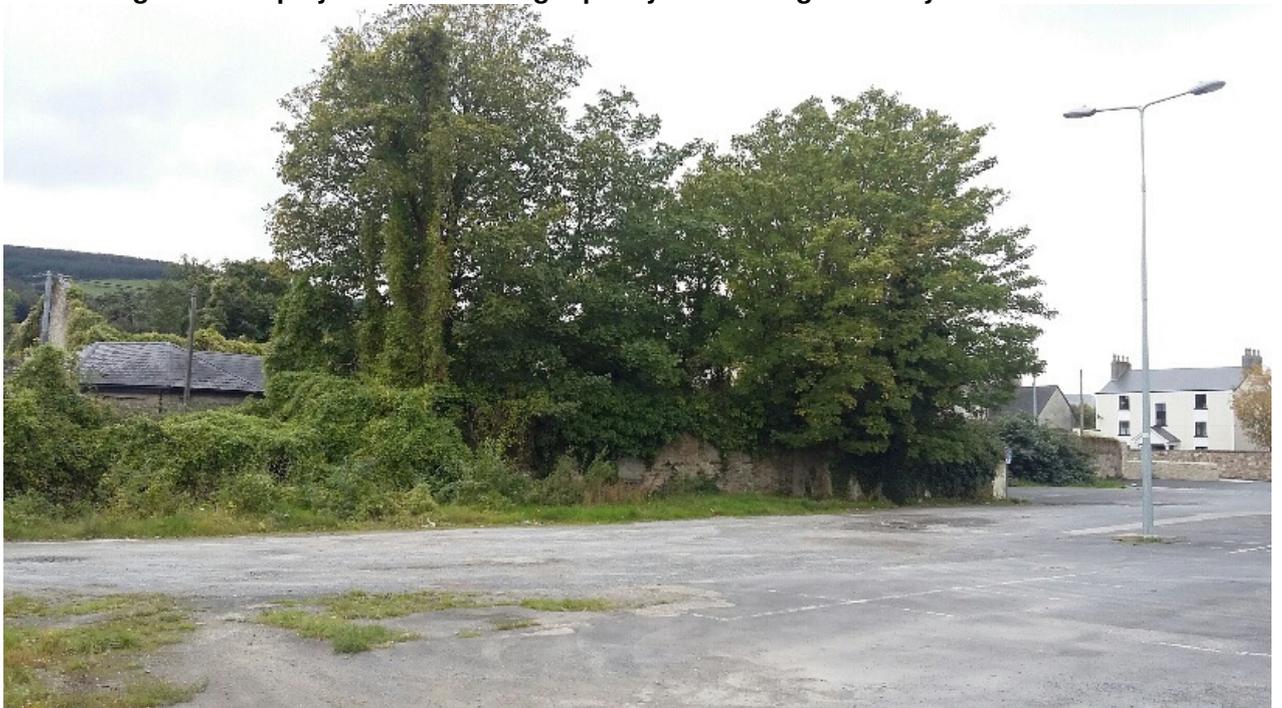
**Figure 4. Displays trees 2201. High quality trees of high amenity value**
