Tipperary County Council

Templemore N62 / L3220 / Mall Junction

Quality Audit Report

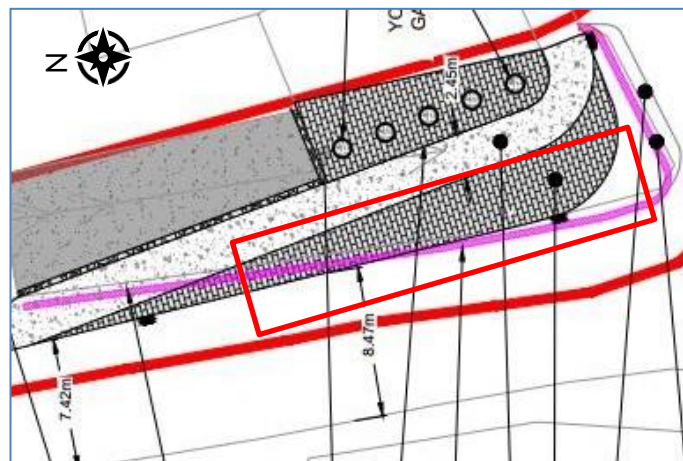
Figure 5-1 Proposed Streetscape Design at the Junction of the N62 and Blackcastle Road

A streetscape area is proposed at the junction of the N62 with the Blackcastle Road within the infilled lands. The Audit Team are concerned the wide streetscape area may give rise to vehicles parking on it. This may result in potential conflicts with pedestrian and vehicles and also give rise to junction visibility issues leading to potential collisions at the junction.

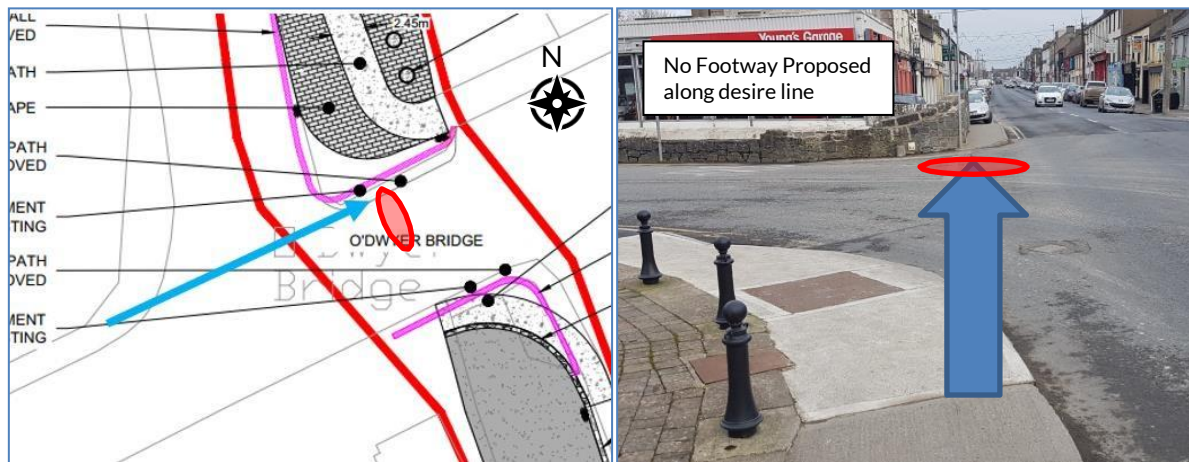
Figure 5-2 Existing Pedestrian Desire Lines across Blackcastle Road

At the streetscape area at the junction of Blackcastle Road and the N62, the roadway at O'Dwyer's's Bridge is proposed to be widened and the footway set back behind the existing parapet line. The Audit Team are concerned this will affect the pedestrian desire lines crossing Blackcastle Road. In particular, the existing infrastructure (i.e. drop kerbs) on the left hand side of the junction will guide visually impaired VRUs into the road carriageway, potentially leading pedestrians stranded in the carriageway and collisions between motorised and pedestrians.

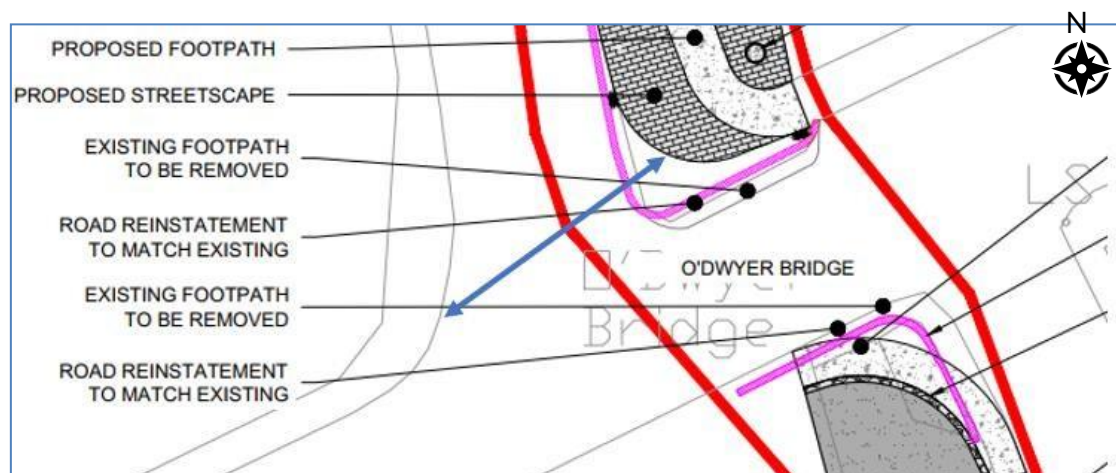
Figure 5-3 Proposed N62 / Blackcastle Road Junction Width

The proposed design shows work only to the eastern side of the N62 / Blackcastle Road junction. The existing wide corner radius on the west side of the junction, in conjunction with the increased eastern corner radius will potentially give rise to higher vehicle speeds turning at the junction. It will also result in increased pedestrian crossing times, which will increase the risk of collisions between motorised and non-motorised road users.

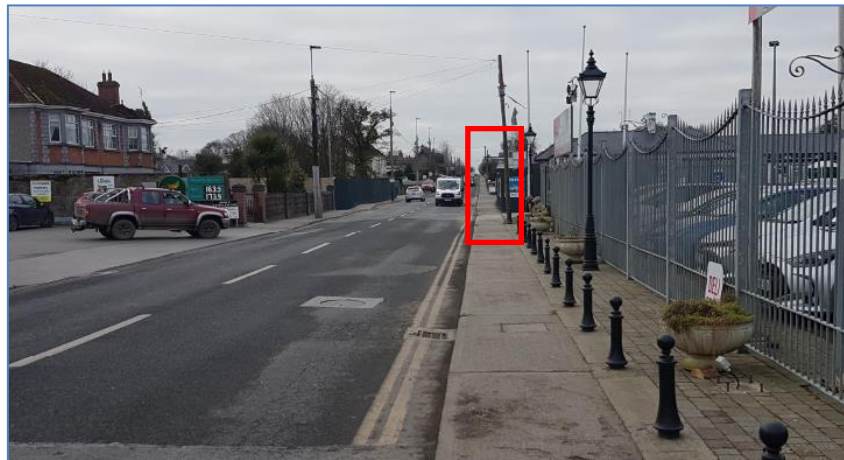
Figure 5-4 Eastbound Approach to the N62 / Blackcastle Road / The Mall Junction

The Audit team observed onsite the presence of warning signage on the minor road approaches to the N62 staggered junction. Warning signage is being provided on the major road approaches

in both directions at quite a distance away from the junction. Significant distance of warning signage to hazards may result in lack of awareness of drivers, believing the warning signs are no longer valid to the area. This could give rise to head on collisions, turning collisions or rear end collisions at the junction as drivers may.

The Design Team should provide staggered junction warning signage on the major road at suitable distances from the hazard.

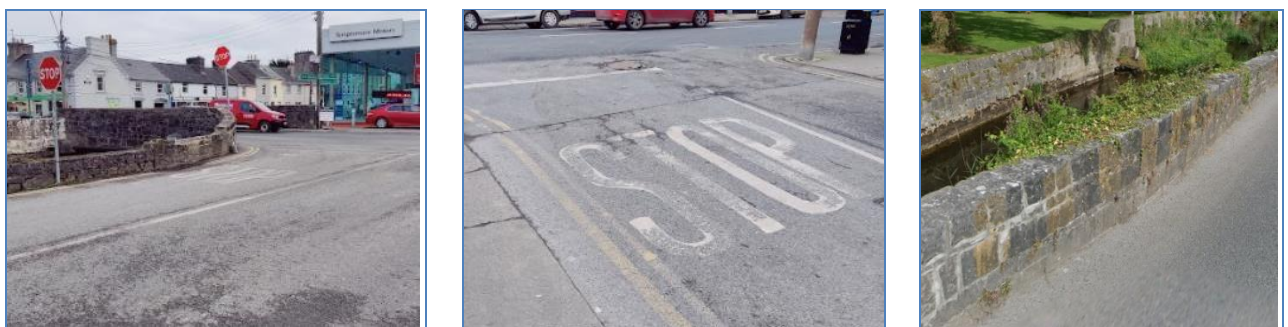
Figure 5-5 Faded Road Markings at the N62 / Blackcastle Road / The Mall Junction and Blackcastle Road

The Audit team observed onsite that the existing road markings within the scheme, in particular, at the N62 / Blackcastle Road / The Mall junction and on the approaches to the junction are heavily worn. The faded line markings could lead to drivers unable to accurately determine the road layout and result in collisions with other road users.

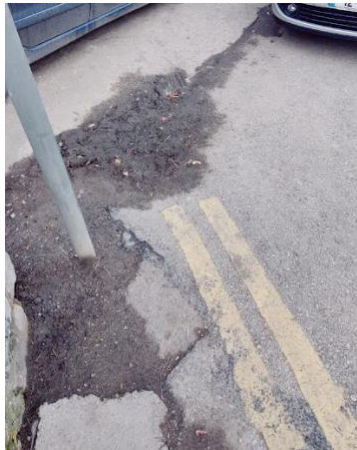
Figure 5-6 Area of Water Ponding on the East of the N62 / Blackcastle Road Junction

The Audit team noted that in the vicinity of the N62 / Blackcastle Road / The Mall junction that areas of potential water ponding were observed onsite. Ponding water could lead to slip hazards for pedestrians or force pedestrians off footways and into the carriageway creating conflict points between motorised and non-motorised road users.

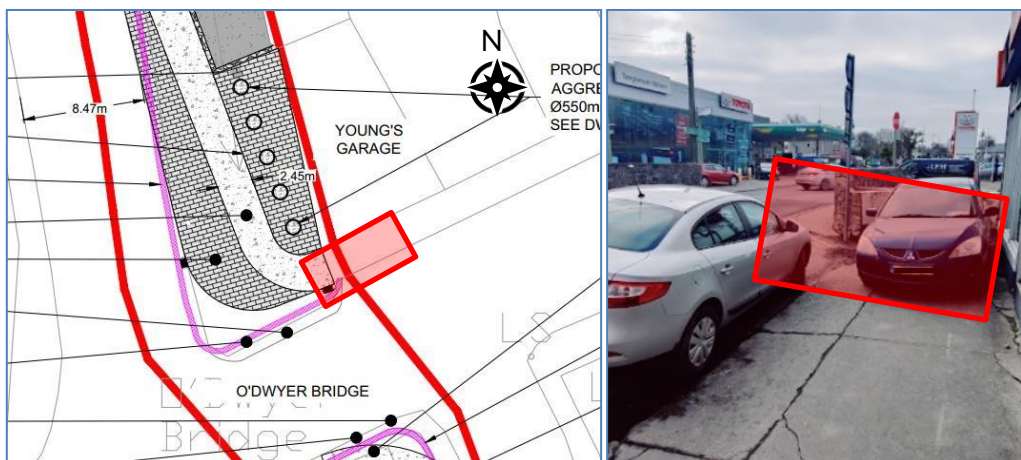
Figure 5-7 Interface of proposed footway and existing footway alignment

The Audit Team observed parking to the east of the N62 / Blackcastle Road junction fronting Young’s Garage. The proposed footway alignment tying into the existing footway, may overlap with this area, displacing vehicles resulting in vehicles parked in closer proximity to the junction negatively impacting on visibility. Or vehicles parked on the proposed footway impeding pedestrians.

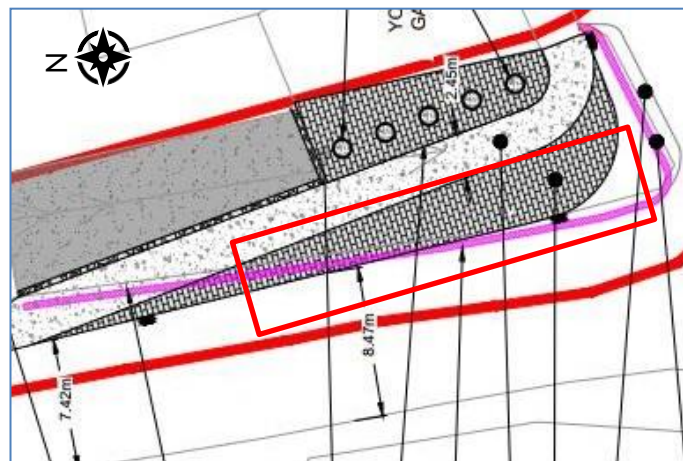
Figure 6-1 Proposed Streetscape Design at the Junction of the N62 and Blackcastle Road

A streetscape area is proposed at the junction of the N62 with the Blackcastle Road within the infilled lands. The Audit Team are concerned the wide streetscape area may give rise to vehicles parking on it. This may result in potential conflicts with pedestrian and vehicles and also give rise to junction visibility issues leading to potential collisions at the junction.

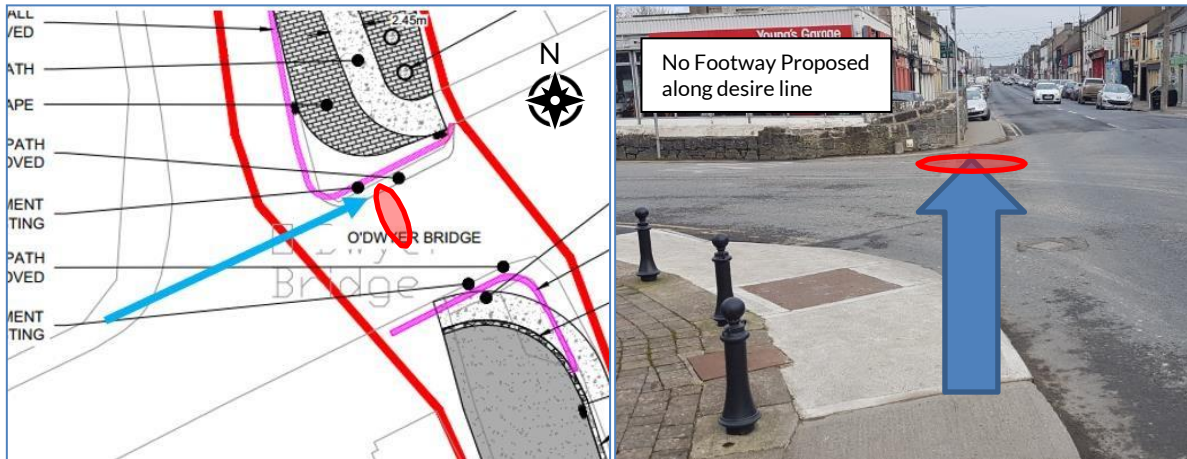
Figure 6-2 Existing Pedestrian Desire Lines across Blackcastle Road

At the streetscape area at the junction of Blackcastle Road and the N62, the roadway at O'Dwyer's's Bridge is proposed to be widened and the footway set back behind the existing parapet line. The Audit Team are concerned this will affect the pedestrian desire lines crossing Blackcastle Road. In particular, the existing infrastructure (i.e. drop kerbs) on the left hand side of the junction will guide visually impaired VRUs into the road carriageway, potentially leading pedestrians stranded in the carriageway and collisions between motorised and pedestrians.

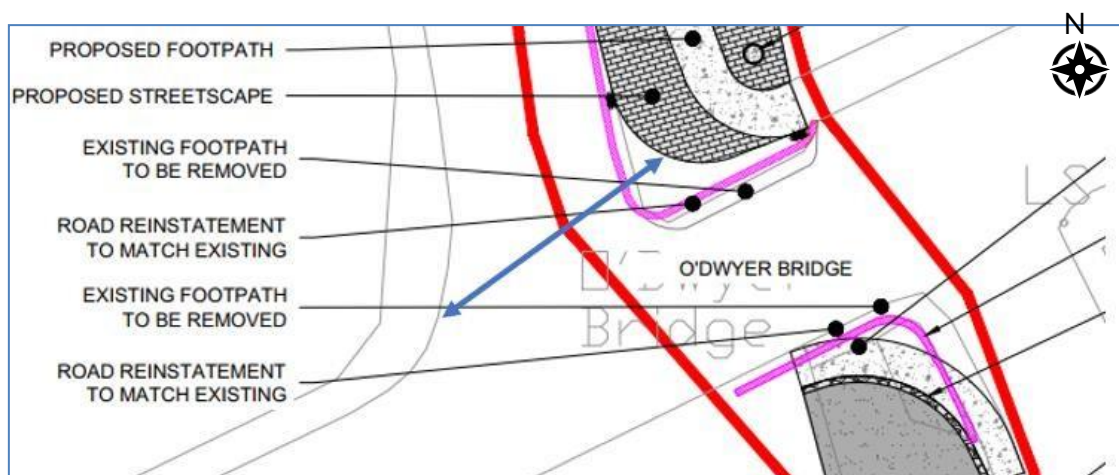
Figure 6-3 Proposed N62 / Blackcastle Road Junction Width

The proposed design shows work only to the eastern side of the N62 / Blackcastle Road junction. The existing wide corner radius on the west side of the junction, in conjunction with the increased eastern corner radius will potentially give rise to higher vehicle speeds turning at the junction. It will also result in increased pedestrian crossing times, which will increase the risk of collisions between motorised and non-motorised road users.

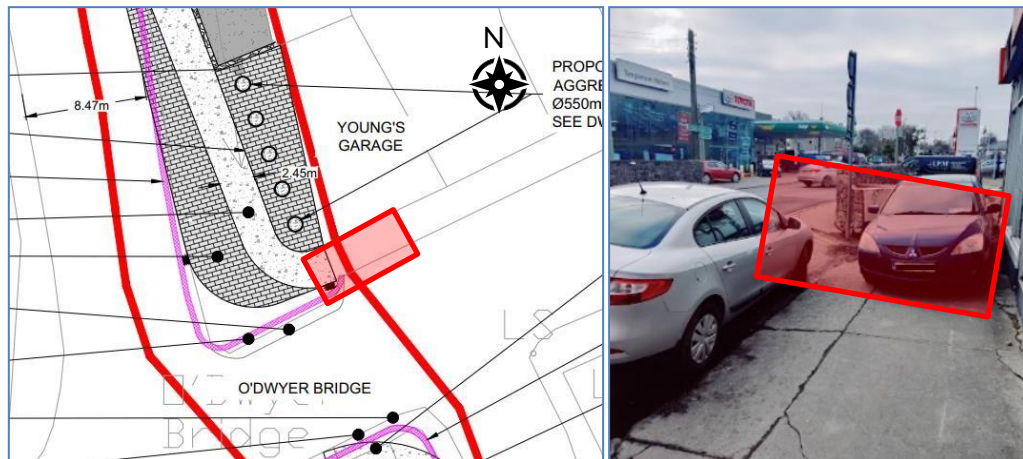
Figure 6-4 Interface of proposed footway and existing footway alignment

The Audit Team observed parking to the east of the N62 / Blackcastle Road junction fronting Young's Garage. The proposed footway alignment tying into the existing footway, may overlap with this area, displacing vehicles resulting in vehicles parked in closer proximity to the junction negatively impacting on visibility. Or vehicles parked on the proposed footway impeding pedestrians.

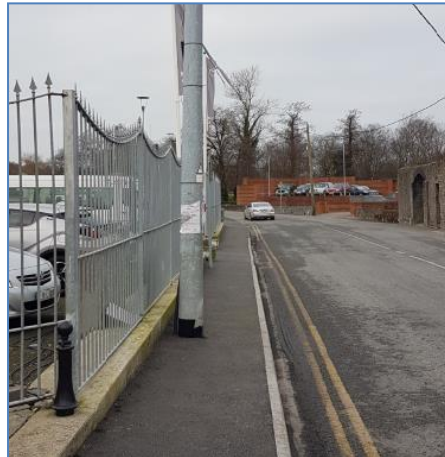
Figure 6-5 Restricted Footway Width on Blackcastle Road adjacent to scheme

The Audit Team noted during the site visit that adjacent to the scheme are areas of restricted footpath widths due to temporary and permanent fixtures.

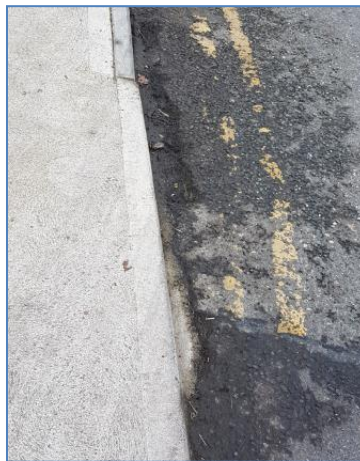
Figure 6-6 Trip hazards at drop kerb locations

The Audit Team noted during the site visit that adjacent to the scheme drop kerbs which exceed the allowable specification tolerances and deterioration of the road pavement are creating trip hazards for pedestrians.

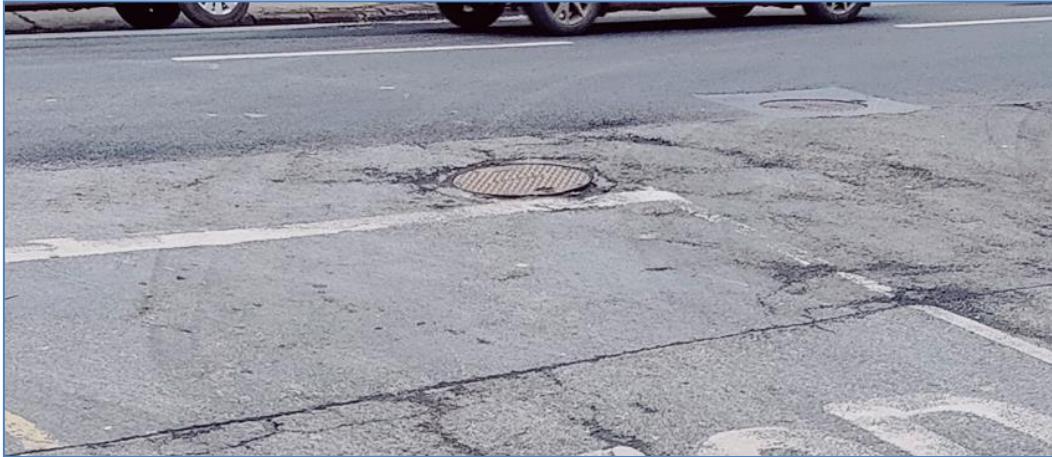
Figure 6-7 Pavement Deterioration at Utility Covers

The Road Safety Audit Team observed during the site visit that pavement deterioration was occurring at some utility covers potentially creating an issue for vehicles and trip hazard for pedestrians.

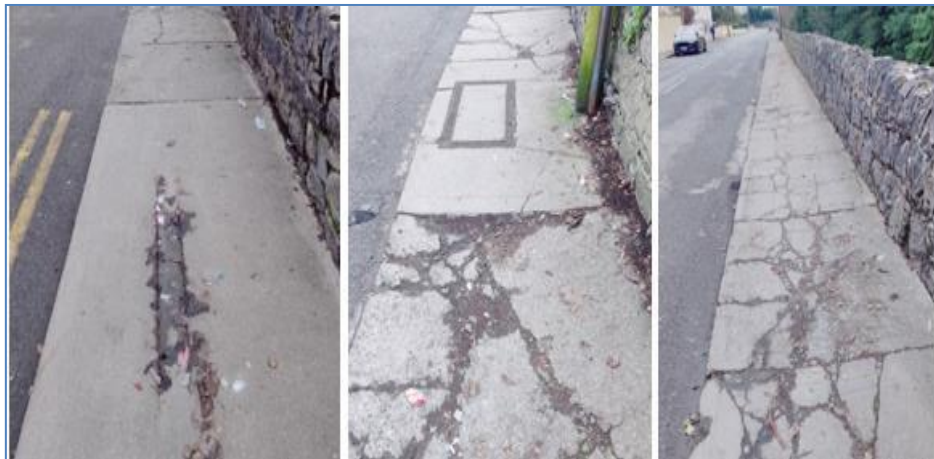
Figure 6-8 Examples of Footway Deterioration adjacent to proposed works

The Road Safety Audit Team observed during the site visit, significant pavement deterioration on the River Mall Road creating a significant safety and trip hazards for pedestrians.

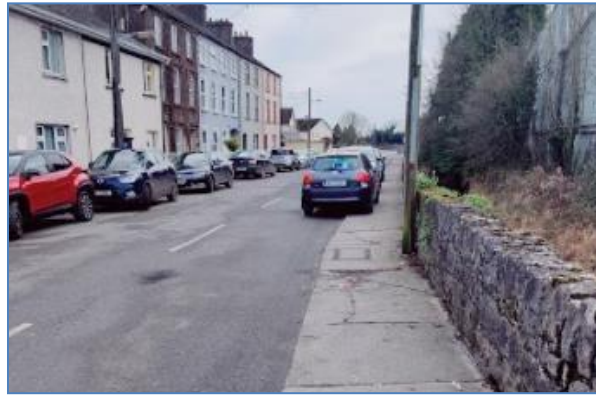
Figure 6-9 Blocked Footways by parked vehicles

The Audit Team observed along The Mall Road, parking is allowed on both sides of the carriageway. On the footway adjacent to the northbound lane, existing low kerb heights are facilitating vehicles parking and blocking footways which may force VRUs (i.e. wheelchairs and pedestrians with buggies) into the carriageway. Significant footway deterioration was also observed along this side of the carriageway, which coincides with the position of parked vehicles.

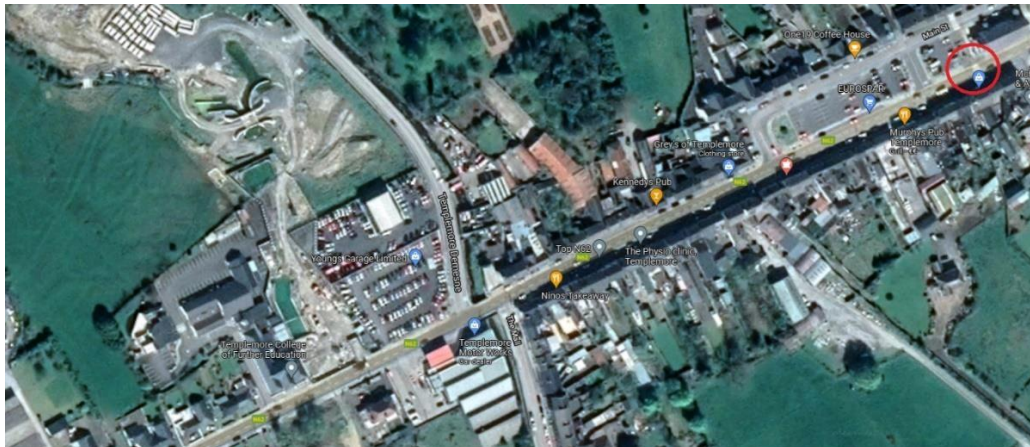
Figure 6-10 Location of Nearest Pedestrian Crossing to the Staggered Junction

The Audit Team noted during the site visit that there is limited provision for pedestrian crossing facilities on the N62. The closest pedestrian crossing facility is located approximately 300m east of the Blackcastle Road / N62 / The Mall staggered junction.

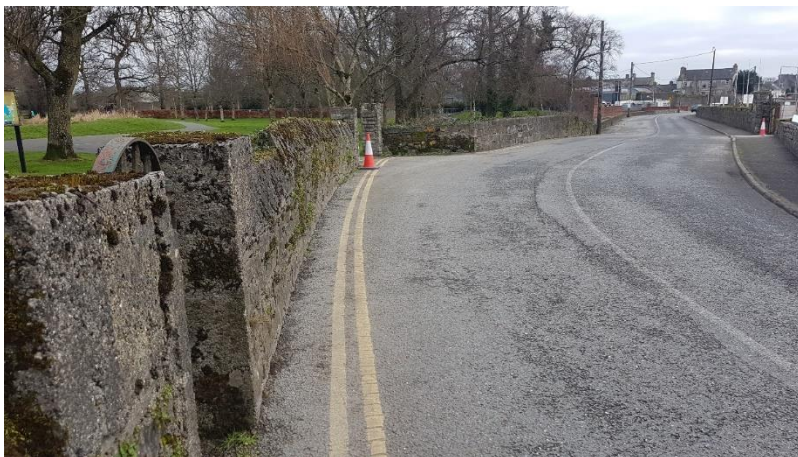
Figure 8-1 Road Markings and Alignment along the Blackcastle Road at the Town Park Entrance

At the northern end of the scheme along the Blackcastle Road, the existing edge of carriageway road markings do not guide vehicles in the same alignment as the road centreline. The edge of carriageway road marking follows the existing boundary wall line. This may lead to vehicles being guiding into pedestrians or the culvert wall especially at times of low visibility (i.e. fog).

The Design Team should provide appropriate delineation measures / boundary treatment measures and warning of the hazard.

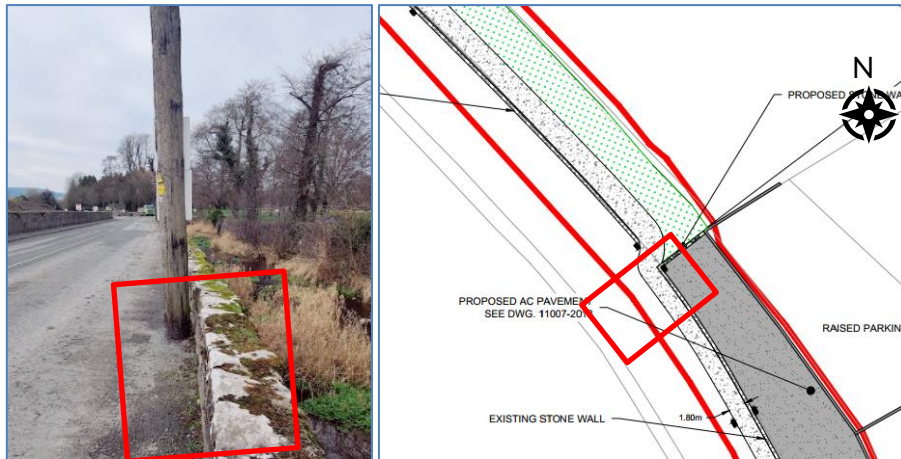
Figure 8-3 Drawing 11007-2014-D01 extract showing interface between road and proposed footway

The footway alignment shifts from behind the culvert wall to online into the existing carriageway (i.e. abrupt change in alignment). The development of the footway occurs instantaneously in line of oncoming traffic without any proposed protection. Wall height may pose an issue to the visibility of small children while the sudden inclusion of a kerb without prior warning could present a significant safety hazard to drivers leading to both pedestrian and vehicular collisions.

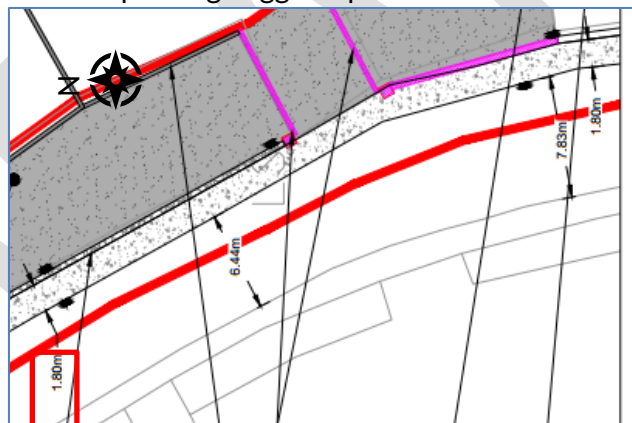
Figure 8-4 Extract of Proposed Footway widths from preliminary design drawings

The audit team note that the proposed width is in line with the absolute minimum standard footway widths, potentially creating a passing hazard for pedestrians forcing them onto the existing carriageway creating a conflict point between vehicles and pedestrians, in particular for wheelchair users and those pushing buggies / prams.

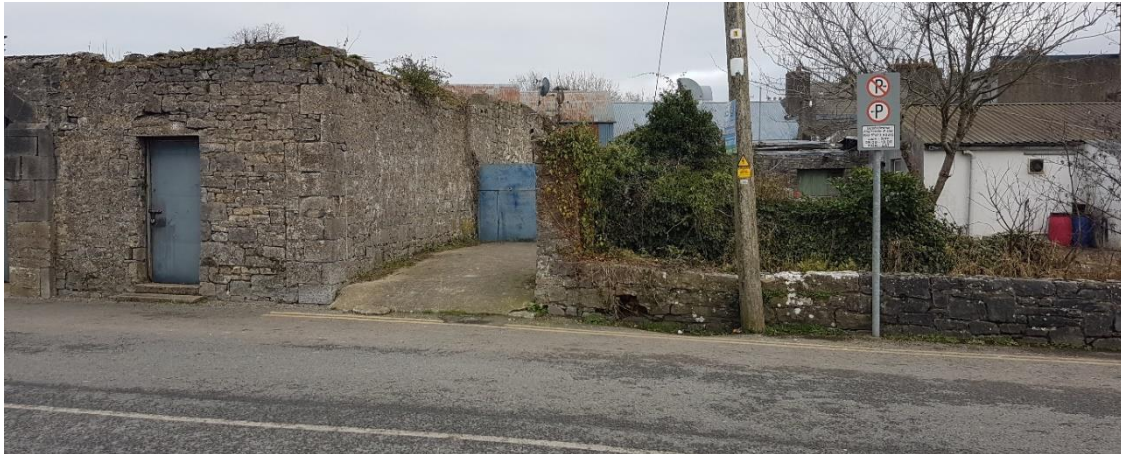
Figure 8-5 Currently Parking allowances along the Blackcastle Road just North of the N62 junction

Along Blackcastle Road, parking is currently permitted commencing a distance of approximately 30m north of the junction with the N62 towards the park pedestrian entrance. The auditors note that if the existing parking provision is maintained upon construction of the new footway, it will result in vehicles parked within the carriageway reducing the road width. Resulting in obstructions to two-way passing vehicular movements with unsuitable visibility to allow yielding. This may result in head on collisions and driver frustration resulting in unsafe road behaviour.

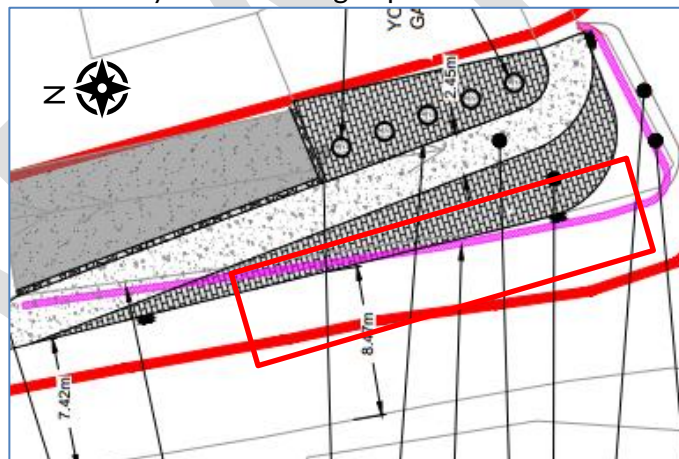
Figure 8-6 Proposed Streetscape Design at the Junction of the N62 and Blackcastle Road

A streetscape area is proposed at the junction of the N62 with the Blackcastle Road within the infilled lands. The Audit Team are concerned the wide streetscape area may give rise to vehicles parking on it. This may result in potential conflicts with pedestrian and vehicles and also give rise to junction visibility issues leading to potential collisions at the junction.

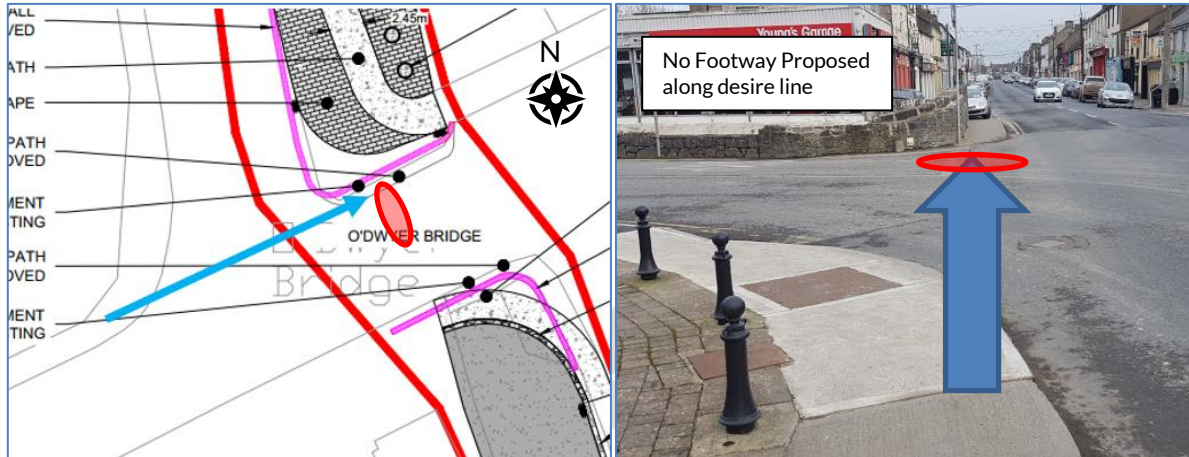
Figure 8-7 Existing Pedestrian Desire Lines across Blackcastle Road

At the streetscape area at the junction of Blackcastle Road and the N62, the roadway at O'Dwyer's Bridge is proposed to be widened and the footway set back behind the existing parapet line. The Audit Team are concerned this will affect the pedestrian desire lines crossing Blackcastle Road. In particular, the existing infrastructure (i.e. drop kerbs) on the left hand side of the junction will guide visually impaired VRUs into the road carriageway, potentially leading pedestrians stranded in the carriageway and collisions between motorised and pedestrians.

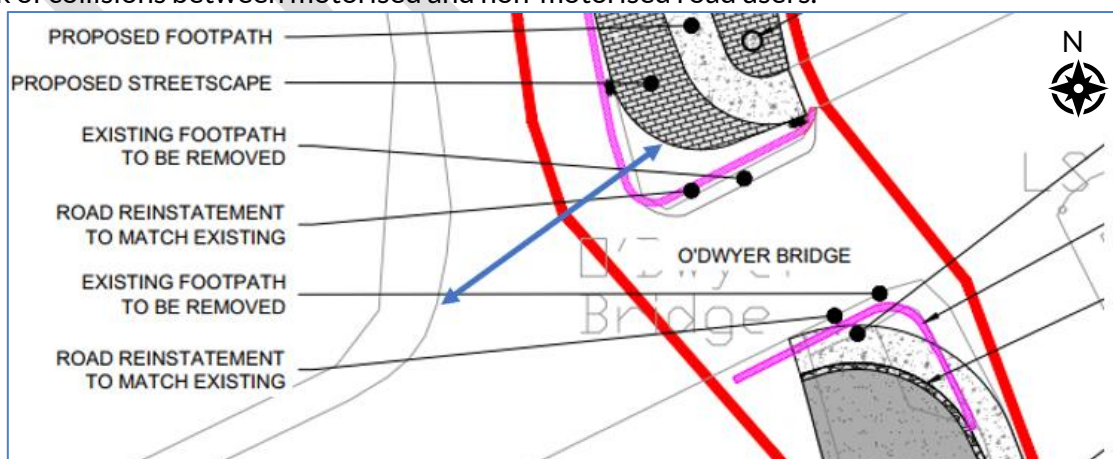
Figure 8-8 Proposed N62 / Blackcastle Road Junction Width

The proposed design shows work only to the eastern side of the N62 / Blackcastle Road junction. The existing wide corner radius on the west side of the junction, in conjunction with the increased eastern corner radius will potentially give rise to higher vehicle speeds turning at the junction. It will also result in increased pedestrian crossing times, which will increase the risk of collisions between motorised and non-motorised road users.

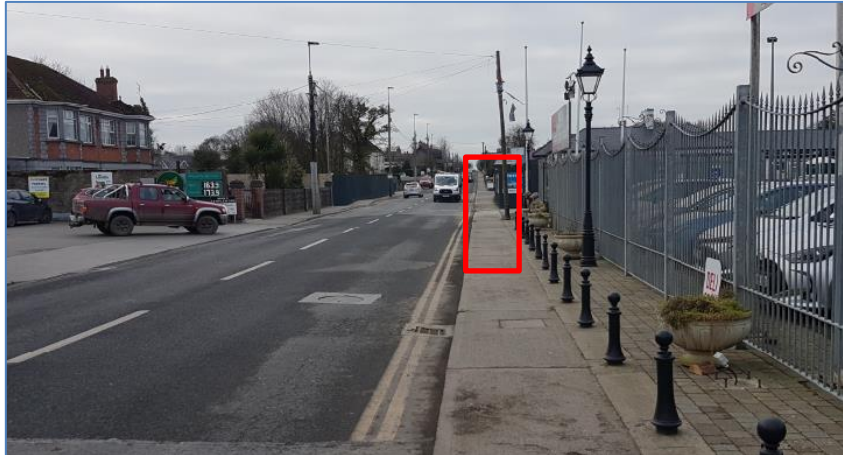
Figure 8-9 Eastbound Approach to the N62 / Blackcastle Road / The Mall Junction

The Audit team observed onsite the presence of warning signage on the minor road approaches to the N62 staggered junction. Warning signage is being provided on the major road approaches in both directions at quite a distance away from the junction. Significant distance of warning signage to hazards may result in lack of awareness of drivers, believing the warning signs are no longer valid to the area. This could give rise to head on collisions, turning collisions or rear end collisions at the junction as drivers may.

The Design Team should provide staggered junction warning signage on the major road at suitable distances from the hazard.

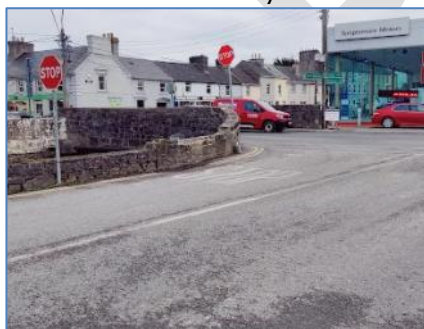
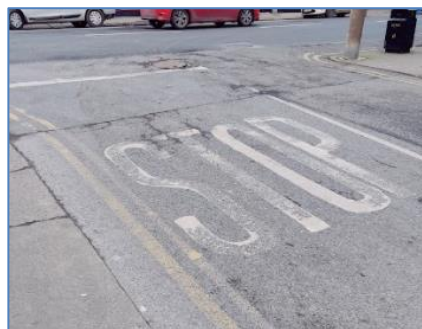
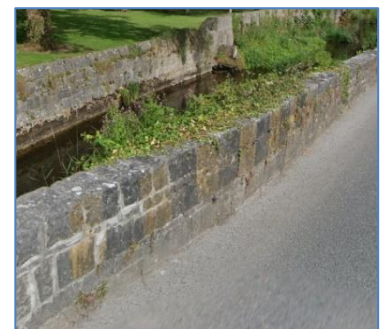
Figure 8-10 Faded Road Markings at the N62 / Blackcastle Road / The Mall Junction and Blackcastle Road

The Audit team observed onsite that the existing road markings within the scheme, in particular, at the N62 / Blackcastle Road / The Mall junction and on the approaches to the junction are heavily worn. The faded line markings could lead to drivers unable to accurately determine the road layout and result in collisions with other road users.

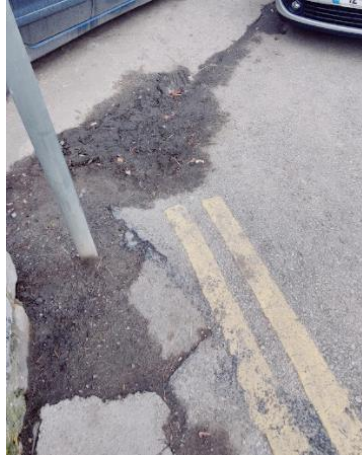
Figure 8-11 Area of Water Ponding on the East of the N62 / Blackcastle Road Junction

The Audit team noted that in the vicinity of the N62 / Blackcastle Road / The Mall junction that areas of potential water ponding were observed onsite. Ponding water could lead to slip hazards for pedestrians or force pedestrians off footways and into the carriageway creating conflict points between motorised and non-motorised road users.

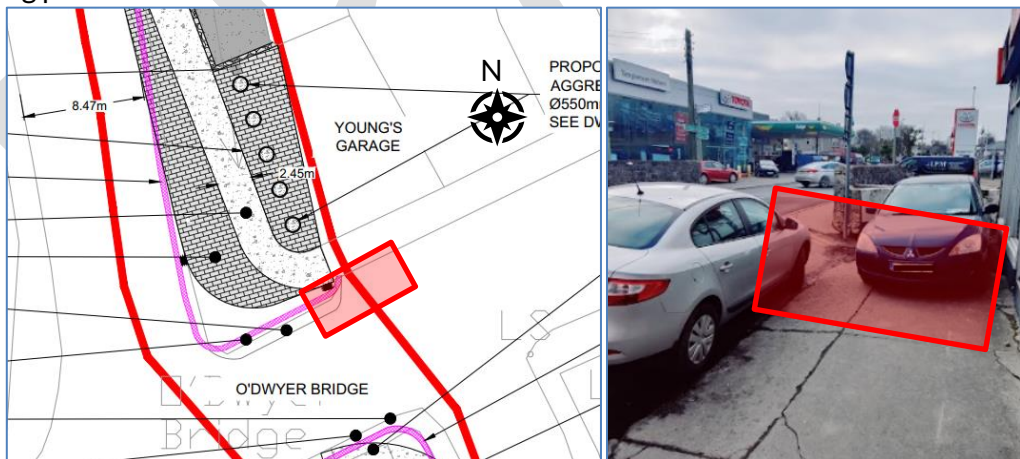
Figure 8-12 Interface of proposed footway and existing footway alignment

The Audit Team observed parking to the east of the N62 / Blackcastle Road junction fronting Young's Garage. The proposed footway alignment tying into the existing footway, may overlap with this area, displacing vehicles resulting in vehicles parked in closer proximity to the junction negatively impacting on visibility. Or vehicles parked on the proposed footway impeding pedestrians.

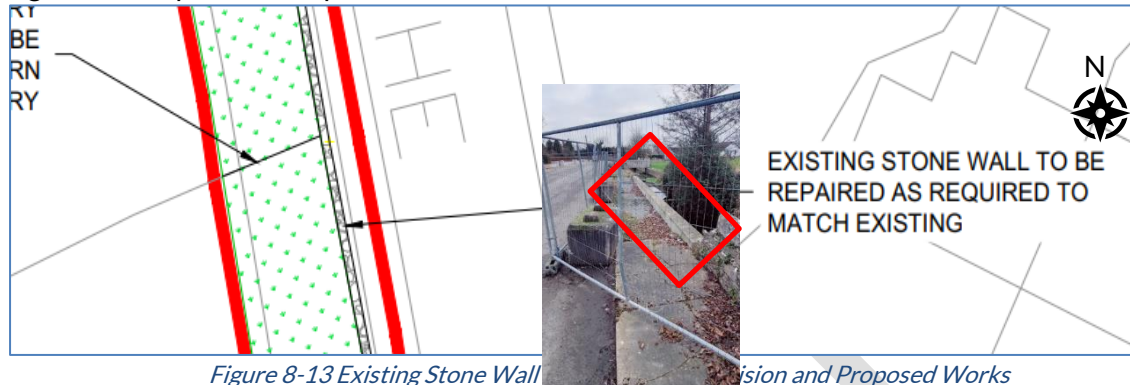
Figure 8-13 Existing Stone Wall Condition and Proposed Works

The Audit Team observed along The Mall Road, the existing footway and culvert wall has been significantly damaged with proposed design noting that *“the existing stone wall to be repaired as required to match existing”*. Retention of the existing footway in the current state is a significant trip hazard to pedestrians.

The footway at this location should be reinstated in combination with the wall repairs.

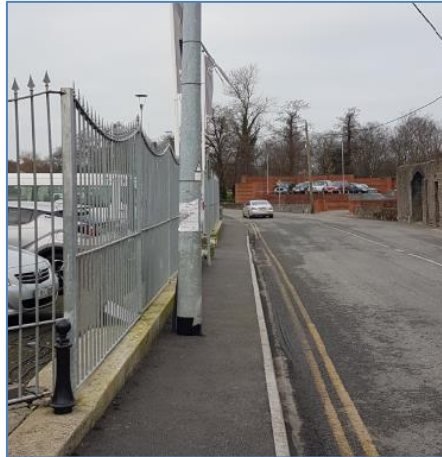
Figure 26-1 Restricted Footway Width on Blackcastle Road adjacent to scheme

The Road Safety Audit Team noted during the site visit that adjacent to the scheme are areas of restricted footpath widths due to temporary and permanent fixtures.

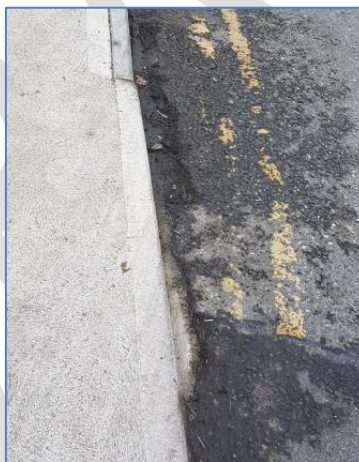
Figure 26-2 Trip hazards at drop kerb locations

The Road Safety Audit Team noted during the site visit that adjacent to the scheme drop kerbs which exceed the allowable specification tolerances and deterioration of the road pavement are creating trip hazards for pedestrians.

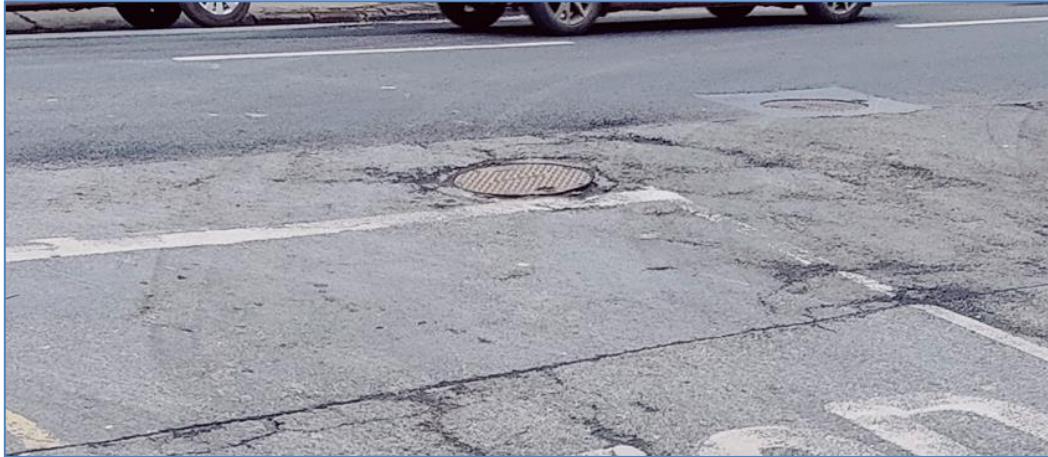
Figure 26-3 Pavement Deterioration at Utility Covers

The Road Safety Audit Team observed during the site visit that pavement deterioration was occurring at some utility covers potentially creating an issue for vehicles and trip hazard for pedestrians.

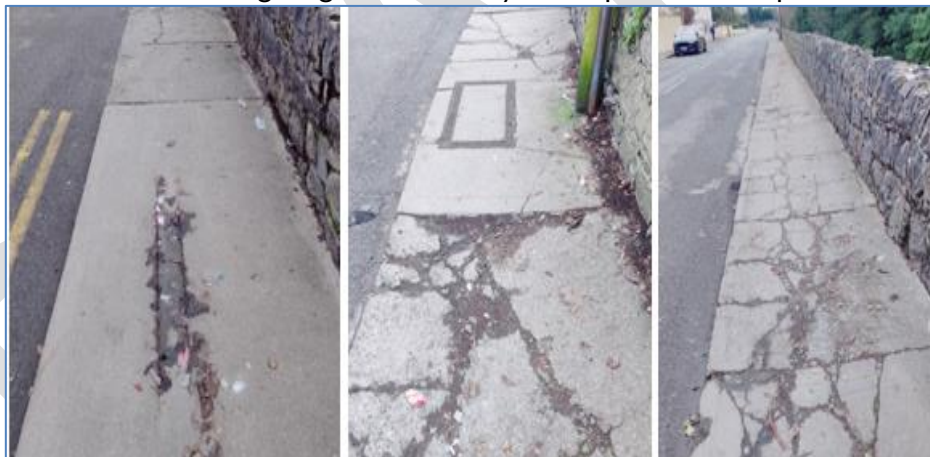
Figure 26-4 Examples of Footway Deterioration adjacent to proposed works

The Road Safety Audit Team observed during the site visit, significant pavement deterioration on the River Mall Road creating a significant safety and trip hazards for pedestrians.

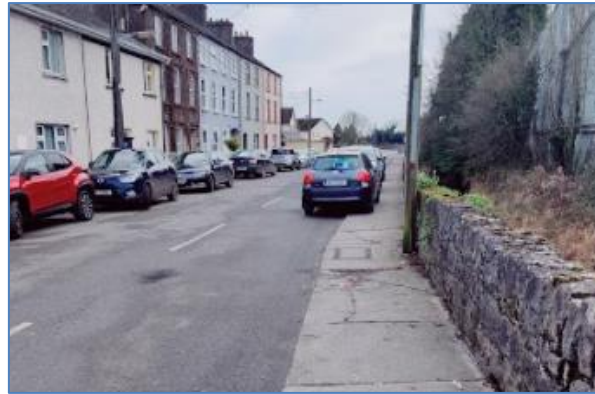
Figure 26-5 Blocked Footways by parked vehicles

The Audit Team observed along The Mall Road, parking is allowed on both sides of the carriageway. On the footway adjacent to the northbound lane, existing low kerb heights are facilitating vehicles parking and blocking footways which may force VRUs (i.e. wheelchairs and pedestrians with buggies) into the carriageway. Significant footway deterioration was also observed along this side of the carriageway, which coincides with the position of parked vehicles.

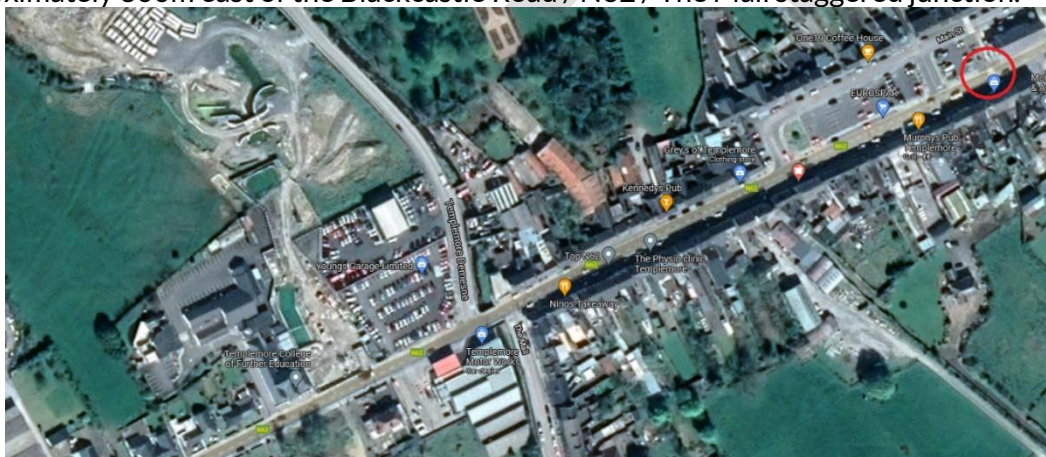
Figure 26-6 Location of Nearest Pedestrian Crossing to the Staggered Junction

The Road Safety Audit Team noted during the site visit that there is limited provision for pedestrian crossing facilities on the N62. The closest pedestrian crossing facility is located approximately 300m east of the Blackcastle Road / N62 / The Mall staggered junction.
