Nenagh Historic & Cultural Quarter, Castle & Prison

Volume 1: Conservation Report - Architectural Inventory & Appraisal

Date: November 2023

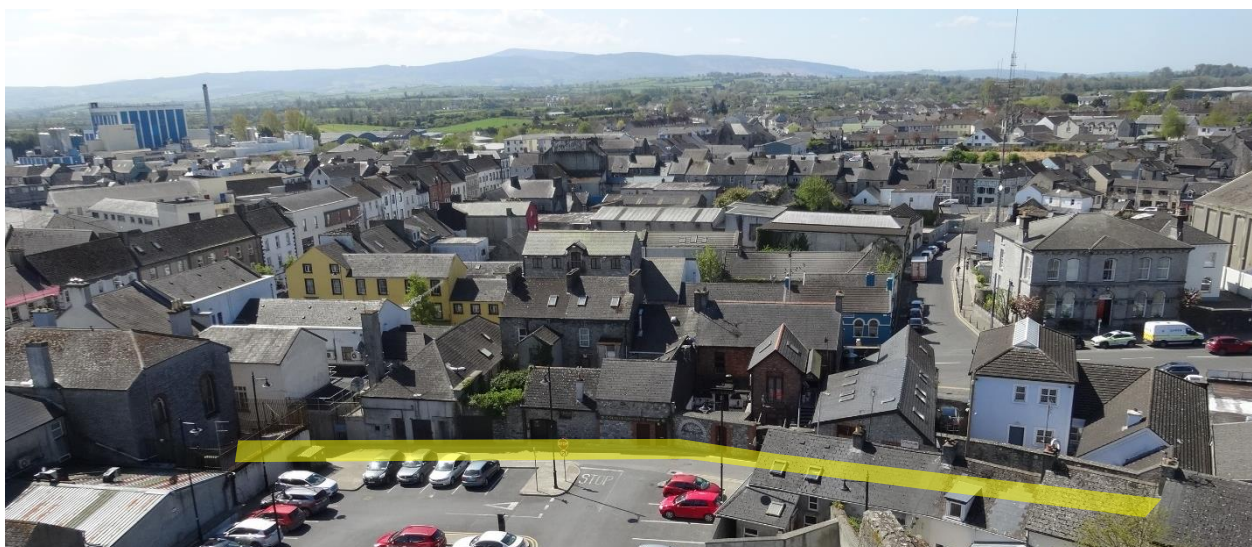
O’Rahilly Street is a perfect example of this narrow lane typology however a demolition has left a large gap site now used as a car park. This has eroded the sense of a lane in part, and it is important that further erosion of this kind is avoided to maintain the historic character.

Fig. 25: O’Rahilly Street follows its original narrow dog leg path however a demolition has left a large gap site to the northeast of the lane. (Bottom central of above image.)

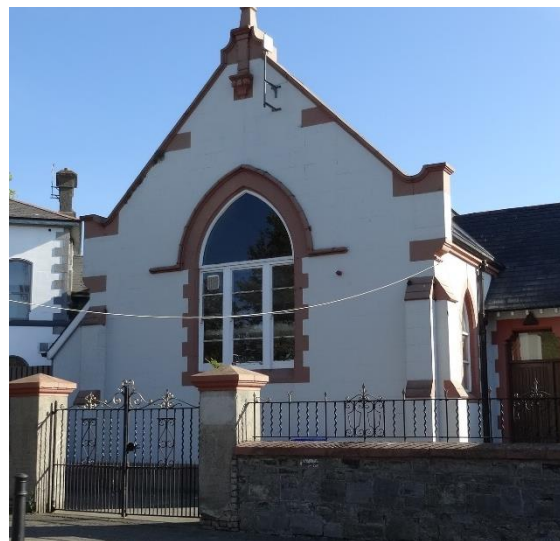
Fig. 35: Inappropriate window replacement. Original lead lights have been lost to the Foróige Youth Services (Former Presbyterian church on Banba Square) .

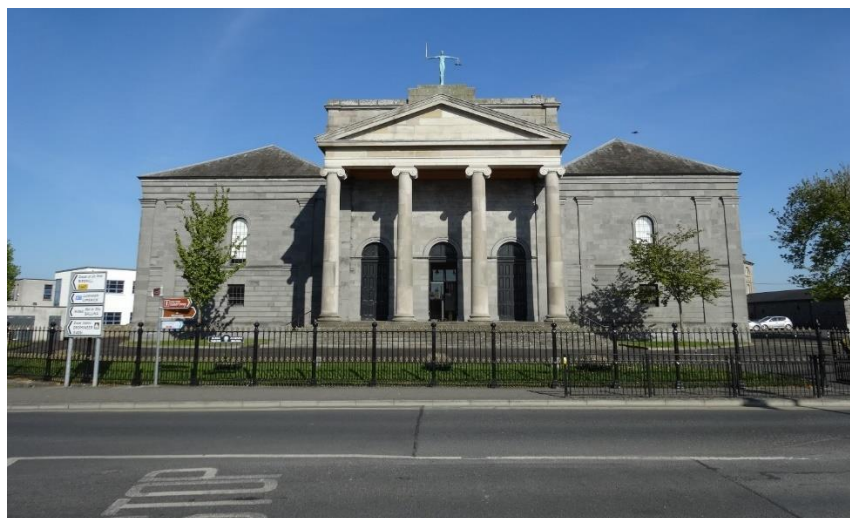
Fig. 43: The courthouse 2021. Railings to the south of the courthouse are intact except the gate posts and gates to the west have been repositioned and the lanterns have been removed. The paving to the base of the railings is modern with concrete kerbs and asphalt road surface.

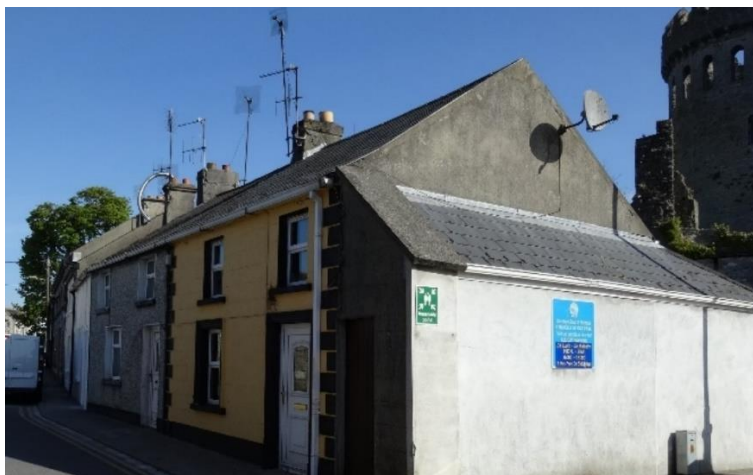
Fig. 52: Residential properties on O'Rahilly street littered with aerials and plastic signage. Here we can see the use of PVC frames windows and doors also.

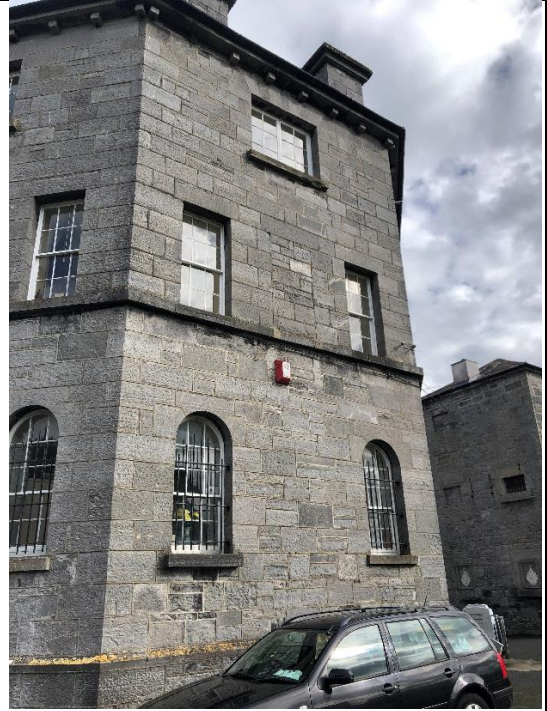
Fig. 63: External view of west elevation showing blocked-up gantry opening at first floor level.

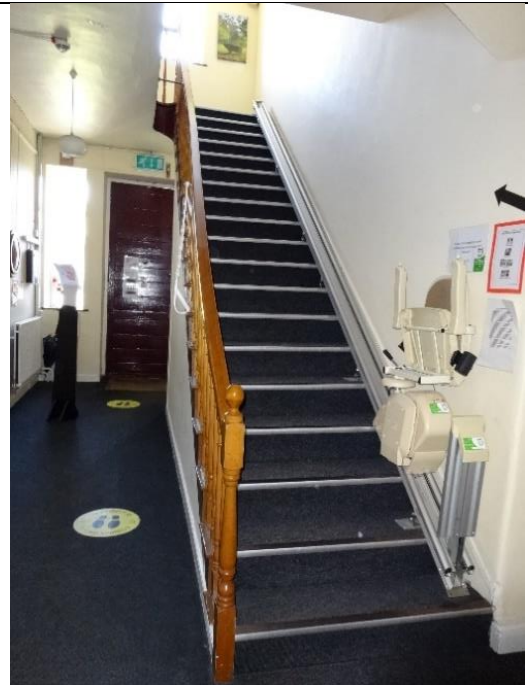
Fig. 79: Principal staircase with modern replacement balusters, newels and handrail.

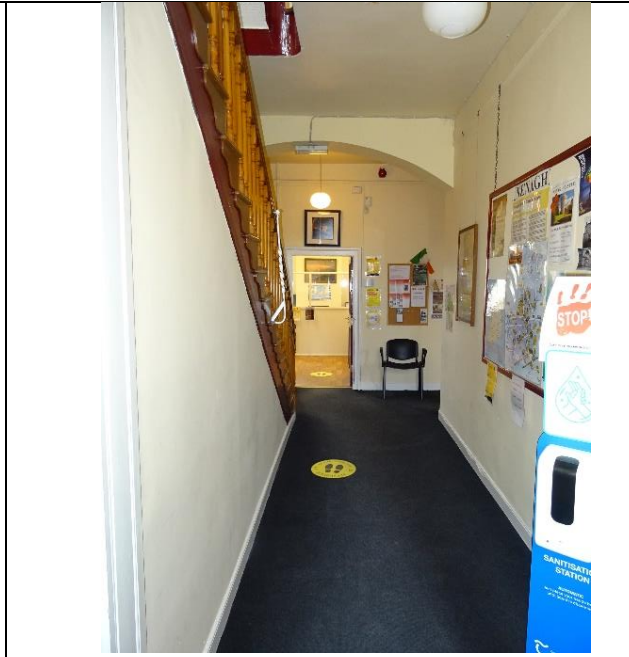
Fig. 81: Principal staircase with modern replacement balusters, newels and handrail.

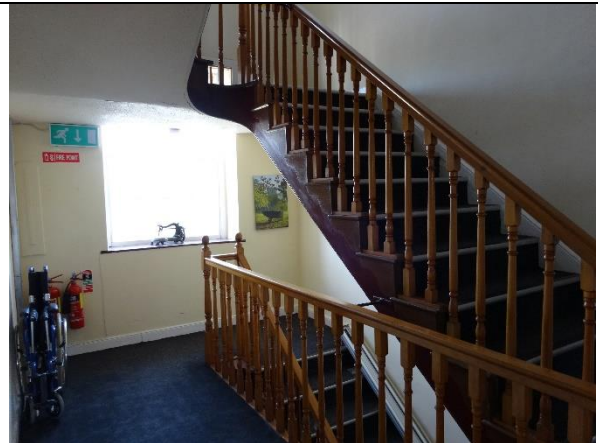
Fig. 91: Replacement balusters, handrails and newels to timber dog-leg stairs.

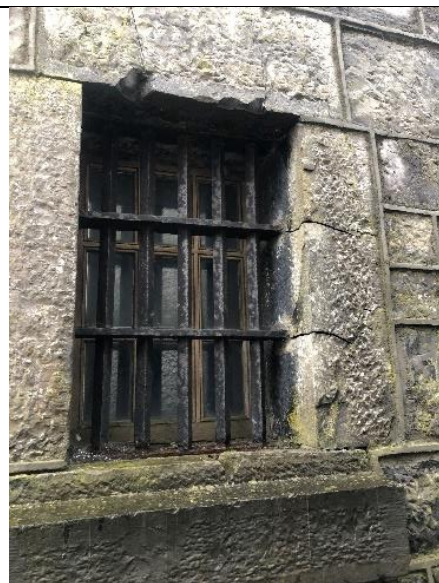
Fig. 127: Window jamb stone with cracks visible where metal security bars have possibly oxidised and caused corrosion jacking.

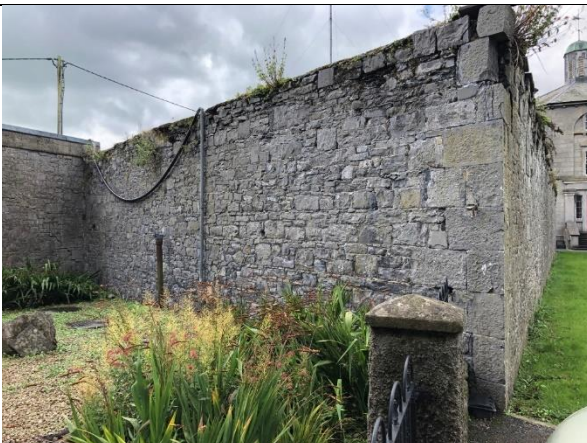
Fig. 146: Return of south side wall, loose blocks visible on corner.

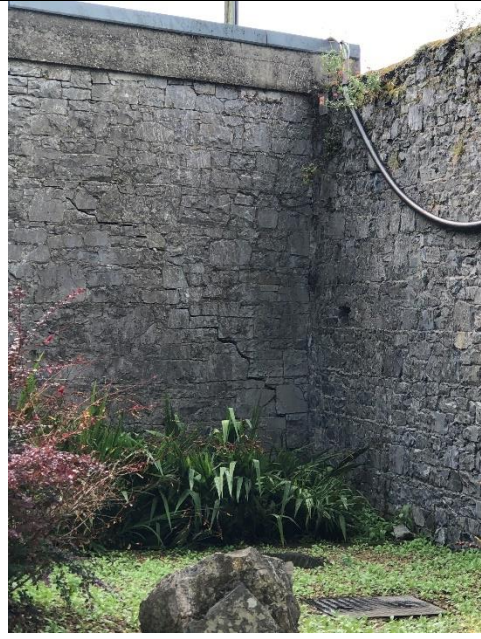
Fig. 149: Crack visible in adjacent wall, near septic tank where access covers are visible.
