Templemore N62 / L3220 / Mall Junction

N62TY_076.0

Road Safety
Improvement Scheme

1 Introduction

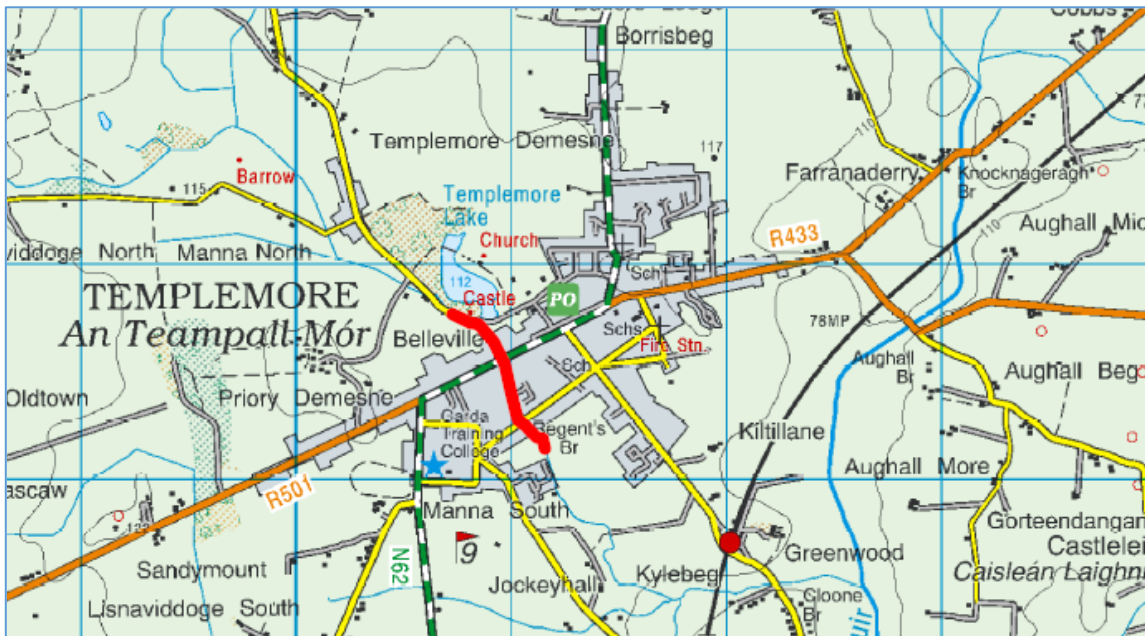
Figure 1-1

This report describes the Preliminary Design carried out for the proposed infilling of the Mall River and associated road improvement works in the town of Templemore, County Tipperary. The site location is shown in Figure 1-1, with the scheme running north - south crossing the N62 national road.

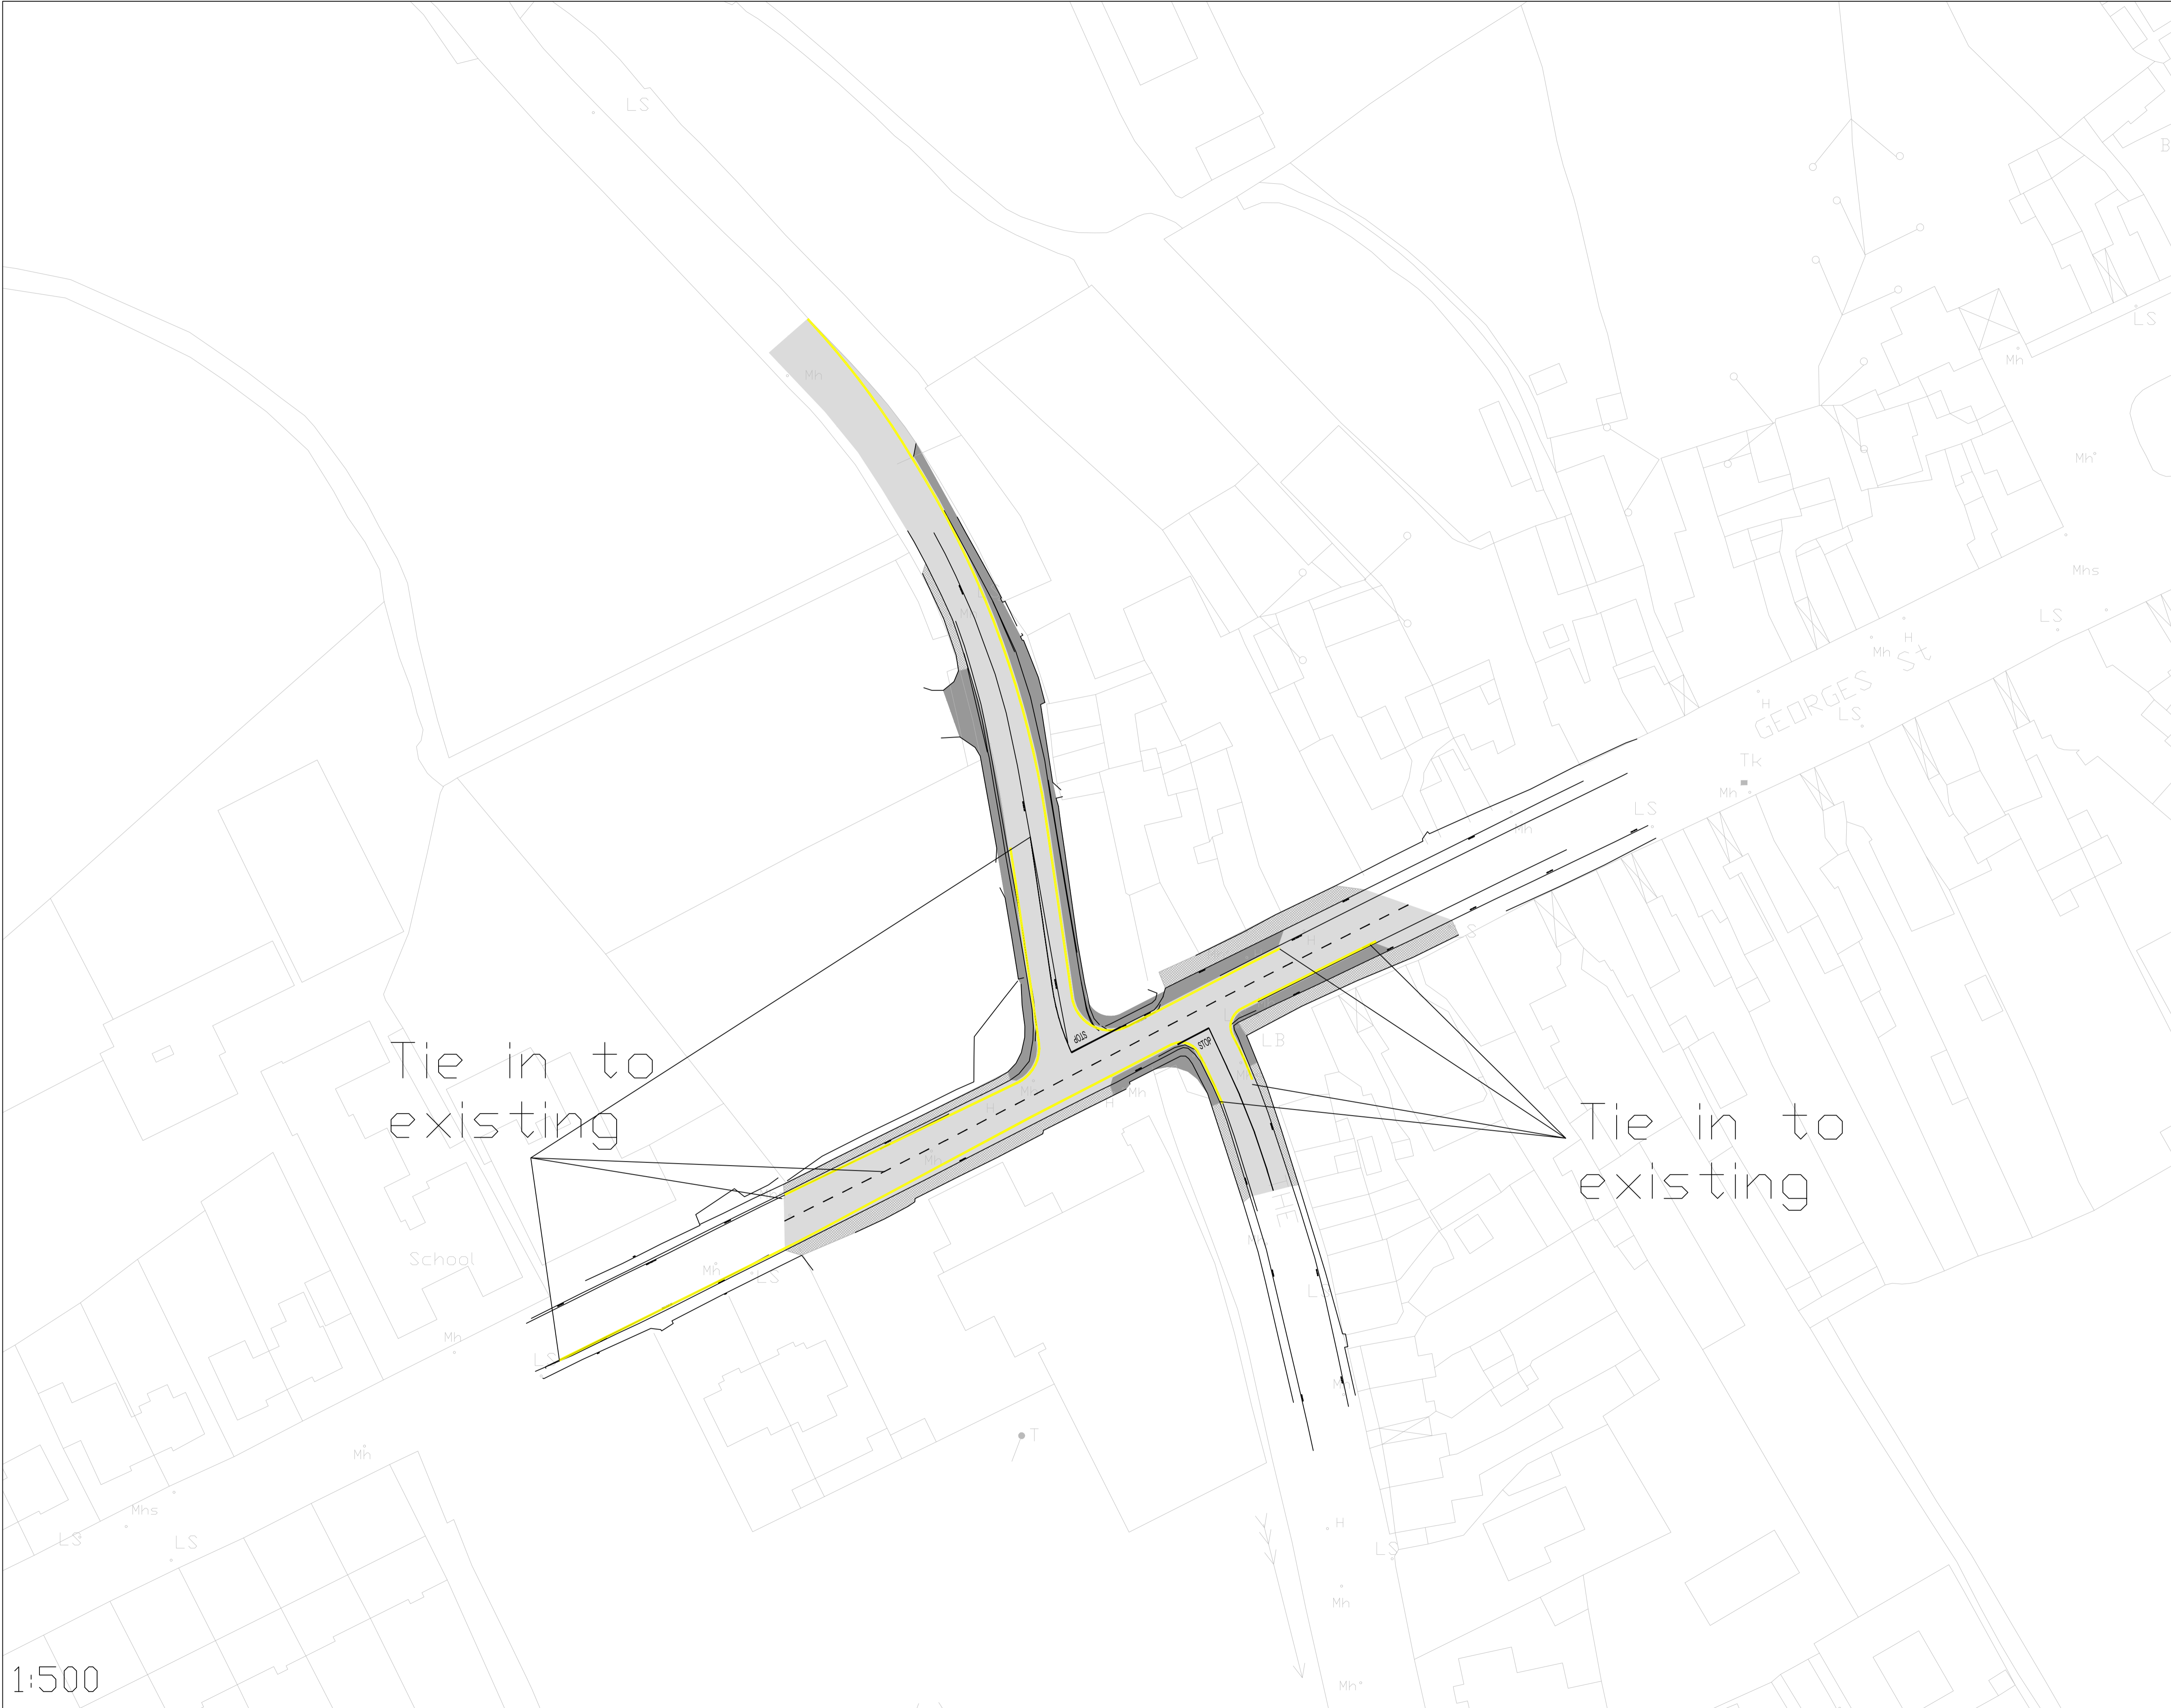
Drawing No.: **11007-1000-04** Revision: **REV A**

Tie in to existing

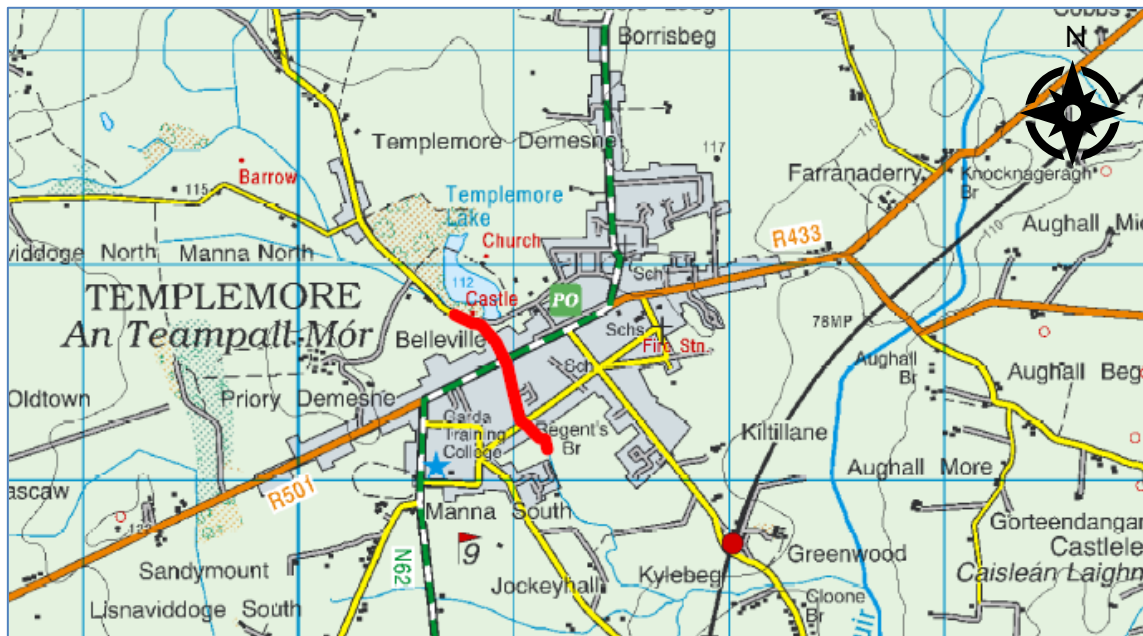
Figure 1-1 Site Location Map (Dwg. No. 11007-2000)

This report describes the Stage 1 Road Safety Audit carried out for the proposed infilling of the Mall River and associated road improvement works in the town of Templemore, County Tipperary. The site location is shown in Figure 1-1, with the scheme running north - south crossing the N62 national road.

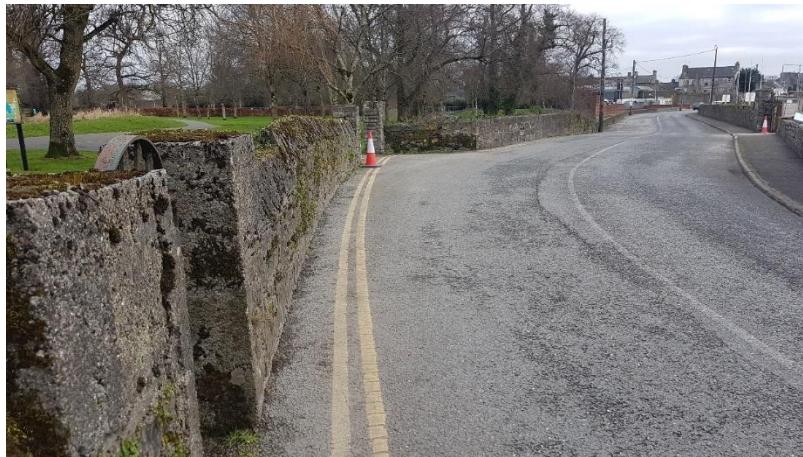
At the northern end of the scheme along the Blackcastle Road, the existing edge of carriageway road markings do not guide vehicles in the same alignment as the road centreline. The edge of carriageway road marking follows the existing boundary wall line. This may lead to vehicles being guided into pedestrians or the culvert wall especially at times of low visibility (i.e. fog).

Figure 2-1 Road Markings and Alignment along the Blackcastle Road at the Town Park Entrance

The Design Team should provide appropriate delineation measures / boundary treatment measures and warning of the hazard.

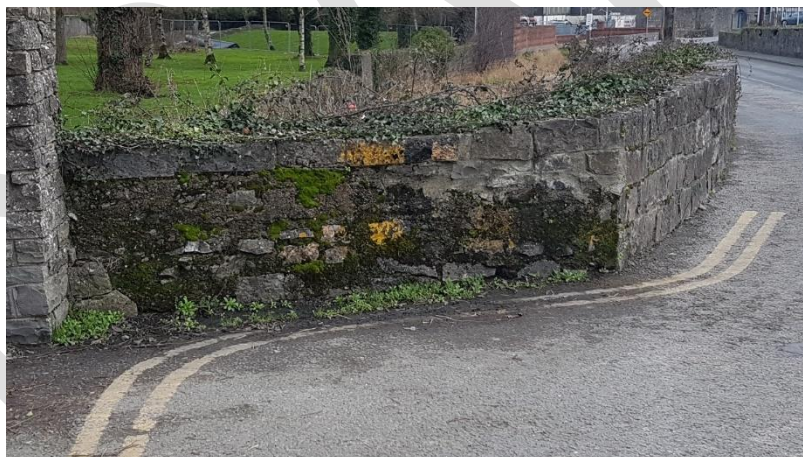
Figure 2-2 Road Markings at Town Park Entrance Boundary Wall

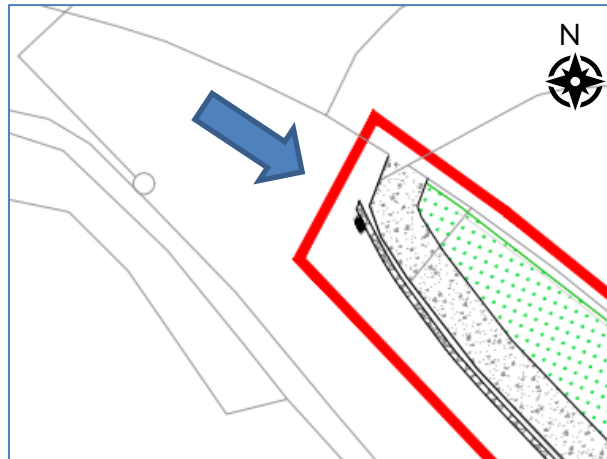
Drawing 11007-2014-D01 shows that in the creation of the proposed footpath between the entrance to the Town Park along the Blackcastle Road, the existing culvert wall will finish directly in line with oncoming traffic. This could result in vehicles striking pedestrians entering/exiting the park or cause a head on collision between a vehicle and the culvert wall

Figure 2-3 Extract Drawing 11007-2014-D01, showing end of wall and intersection with new pedestrian access point to the park

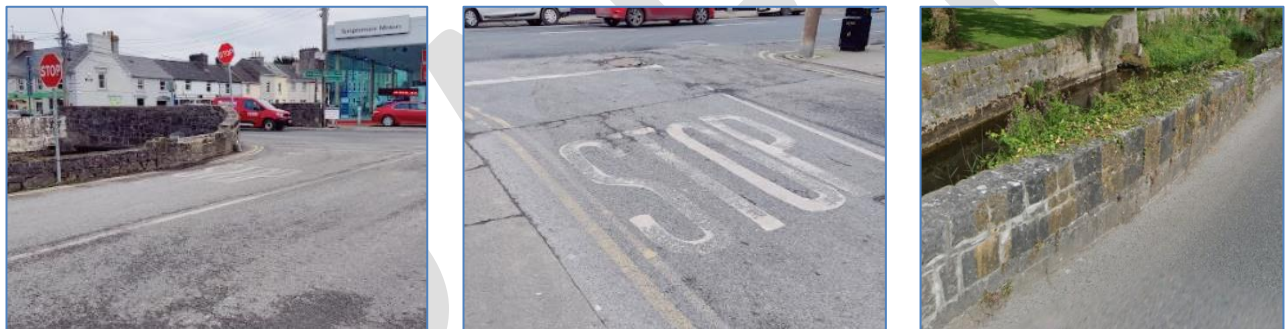
The Audit team observed onsite that the existing road markings within the scheme, in particular, at the N62 / Blackcastle Road / The Mall junction and on the approaches to the junction are heavily worn. The faded line markings could lead to drivers unable to accurately determine the road layout and result in collisions with other road users.

Figure 2-11 Faded Road Markings at the N62 / Blackcastle Road / The Mall Junction and Blackcastle Road

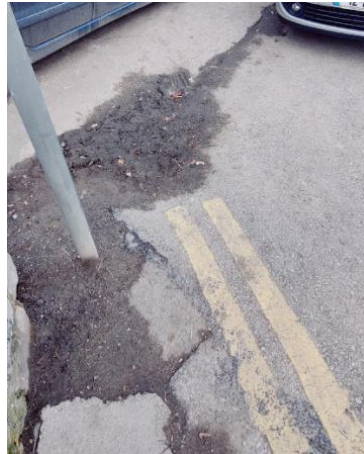
The Audit team noted that in the vicinity of the N62 / Blackcastle Road / The Mall junction that areas of potential water ponding were observed onsite. Ponding water could lead to slip hazards for pedestrians or force pedestrians off footways and into the carriageway creating conflict points between motorised and non-motorised road users.

Figure 2-12 Area of Water Ponding on the East of the N62 / Blackcastle Road Junction

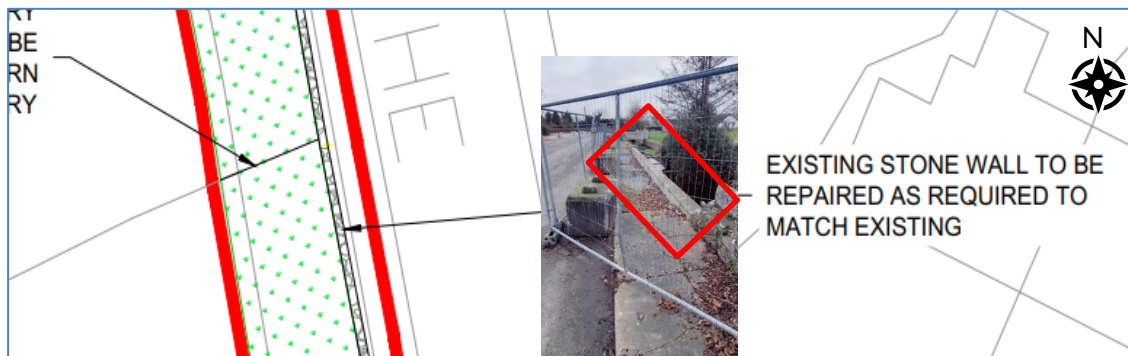
The Audit Team observed along The Mall Road, the existing footway and culvert wall has been significantly damaged with proposed design noting that *“the existing stone wall to be repaired as required to match existing”*. Retention of the existing footway in the current state is a significant trip hazard to pedestrians.

Figure 2-14 Existing Stone Wall and Footpath provision and Proposed Works

The footway at this location should be reinstated in combination with the wall repairs.

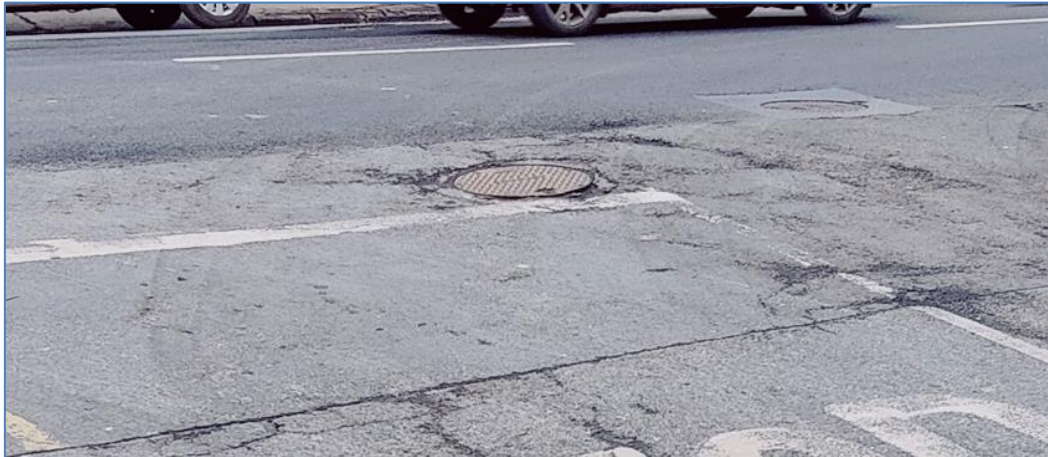
The Road Safety Audit Team observed during the site visit that pavement deterioration was occurring at some utility covers potentially creating an issue for vehicles and trip hazard for pedestrians.

Figure 3-3 Pavement Deterioration at Utility Covers

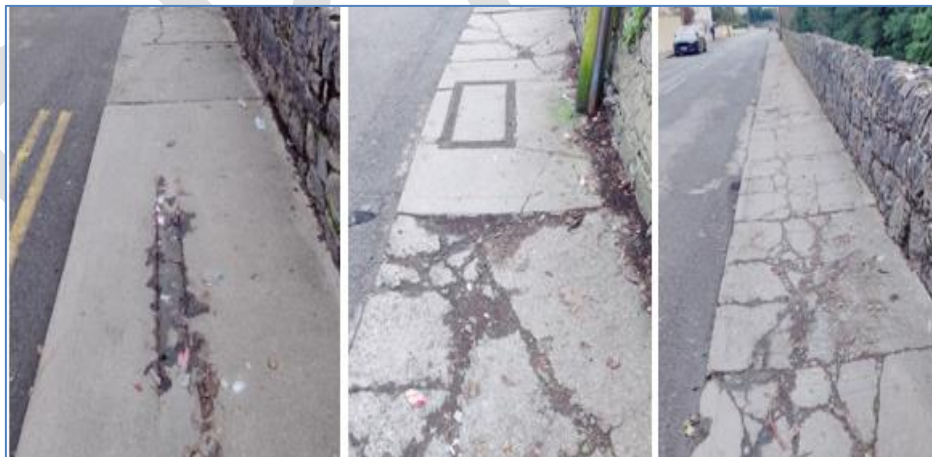
The Road Safety Audit Team observed during the site visit, significant pavement deterioration on the River Mall Road creating a significant safety and trip hazards for pedestrians.

Figure 3-4 Examples of Footway Deterioration adjacent to proposed works

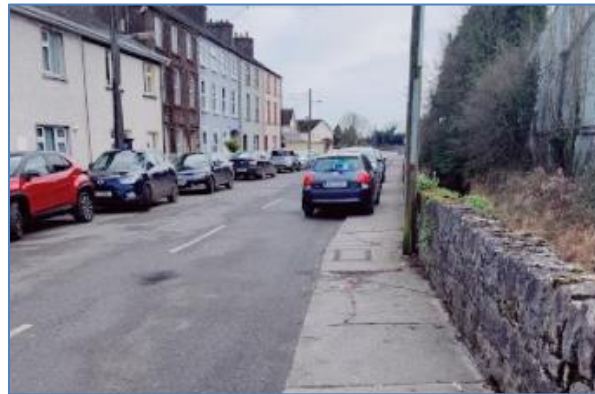
The Audit Team observed along The Mall Road, parking is allowed on both sides of the carriageway. On the footway adjacent to the northbound lane, existing low kerb heights are facilitating vehicles parking and blocking footways which may force VRUs (i.e. wheelchairs and pedestrians with buggies) into the carriageway. Significant footway deterioration was also

observed along this side of the carriageway, which coincides with the position of parked vehicles.

Figure 3-5 Blocked Footways by parked vehicles

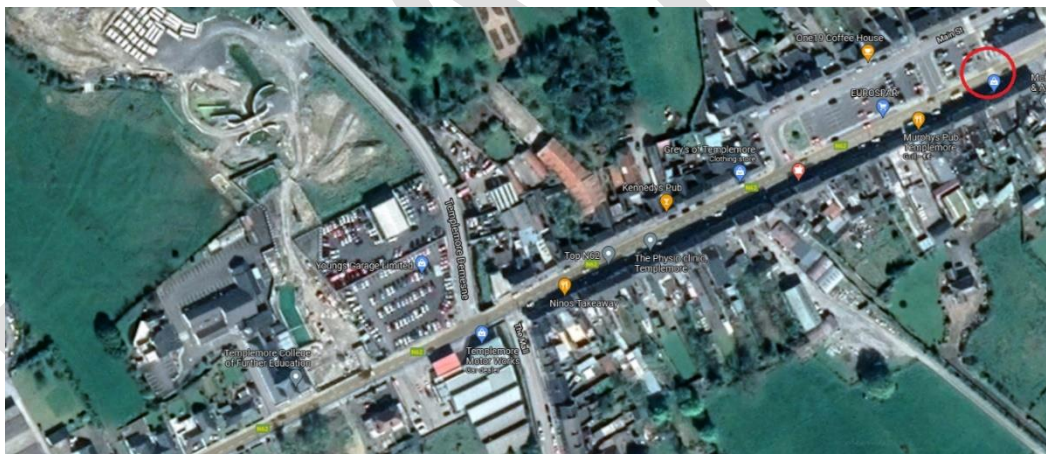
The Road Safety Audit Team noted during the site visit that there is limited provision for pedestrian crossing facilities on the N62. The closest pedestrian crossing facility is located approximately 300m east of the Blackcastle Road / N62 / The Mall staggered junction.

Figure 3-6 Location of Nearest Pedestrian Crossing to the Staggered Junction
