Tipperary County Council

Templemore N62 / L3220 / Mall Junction

Quality Audit Report

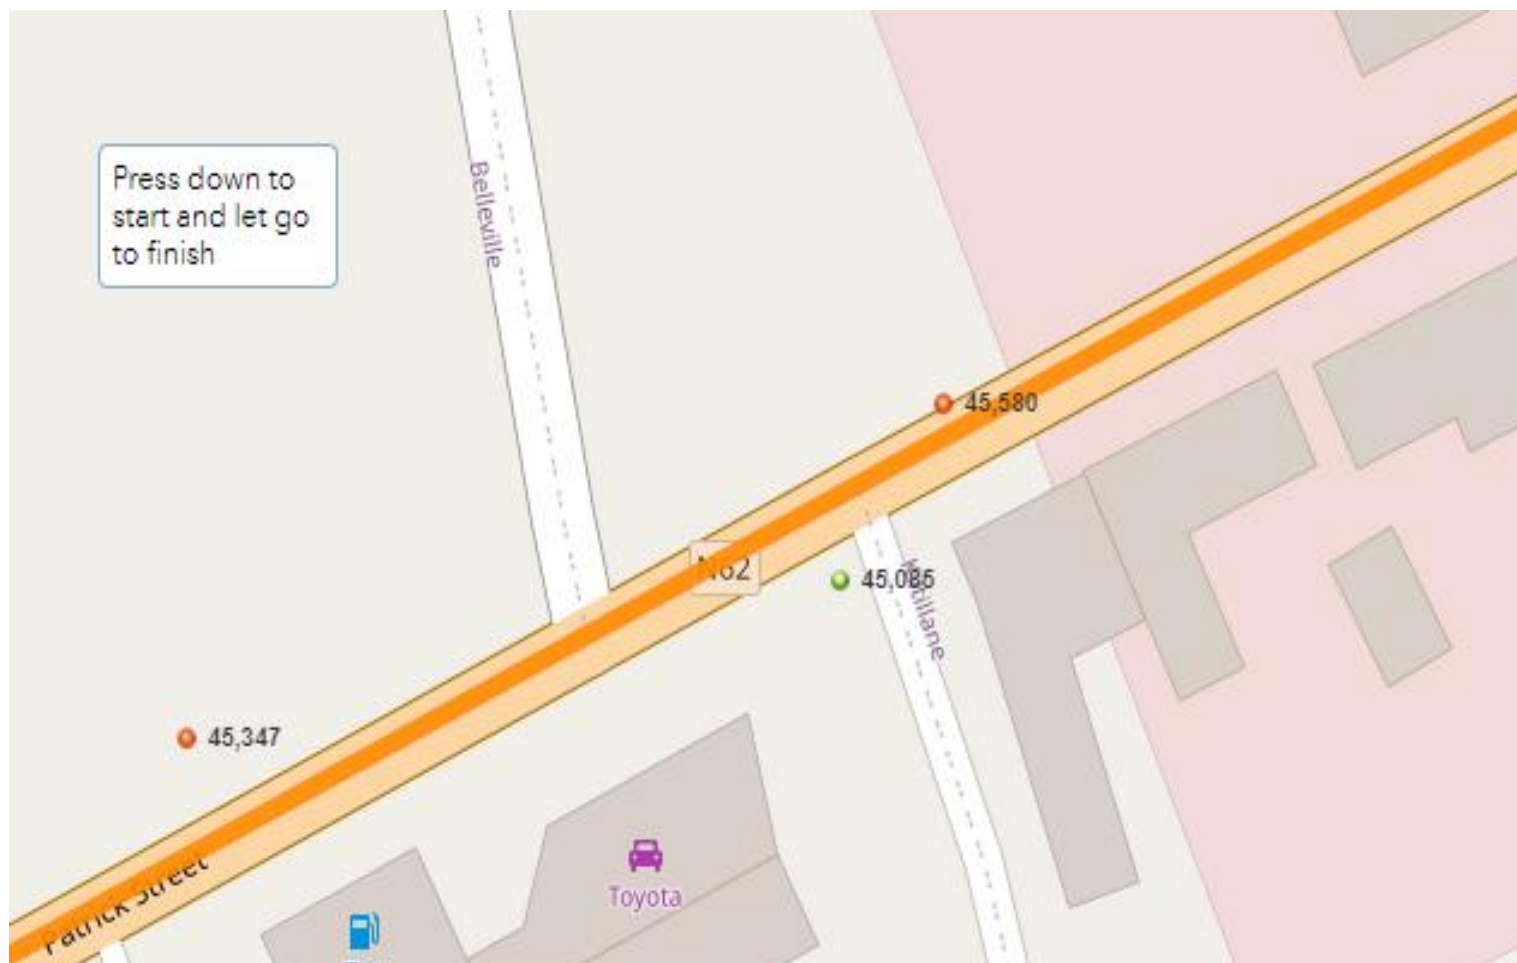
TAG_ID	MAINLINE ISSUE	SEVERITY	LIKELIHOOD RISK	BROAD SOLUTION	FEASIBILITY_STAGE SOLUTION	SKETCH	COST
45085 M	Drivers may exit junction without adequate knowledge of oncoming vehicles on the main road.	21	7 Level 3	Minor Alignment - Landtake Required	Provide adequate sight distance to the left by relocating objects obscuring view of oncoming traffic	N	20000
45347 M	Conflict between pedestrians and motorised vehicles	15	7 Level 3	VRU Provision	Review layout of junction and provide for vulnerable road users	N	2000
45580 M	Conflict between pedestrians and motorised vehicles	15	7 Level 3	VRU Provision	Review layout of junction and provide for vulnerable road users	N	2000

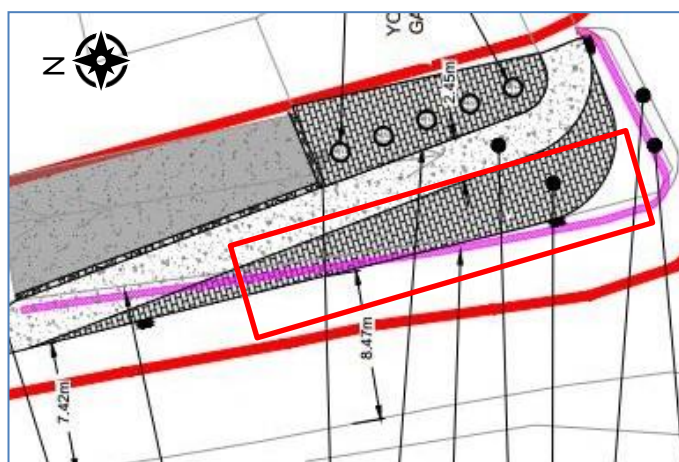
Figure 2-1 Proposed Streetscape Design at the Junction of the N62 and Blackcastle Road

A streetscape area is proposed at the junction of the N62 with the Blackcastle Road within the infilled lands. The Audit Team are concerned the wide streetscape area may give rise to vehicles parking on it. This may result in potential conflicts with pedestrian and vehicles and also give rise to junction visibility issues leading to potential collisions at the junction.

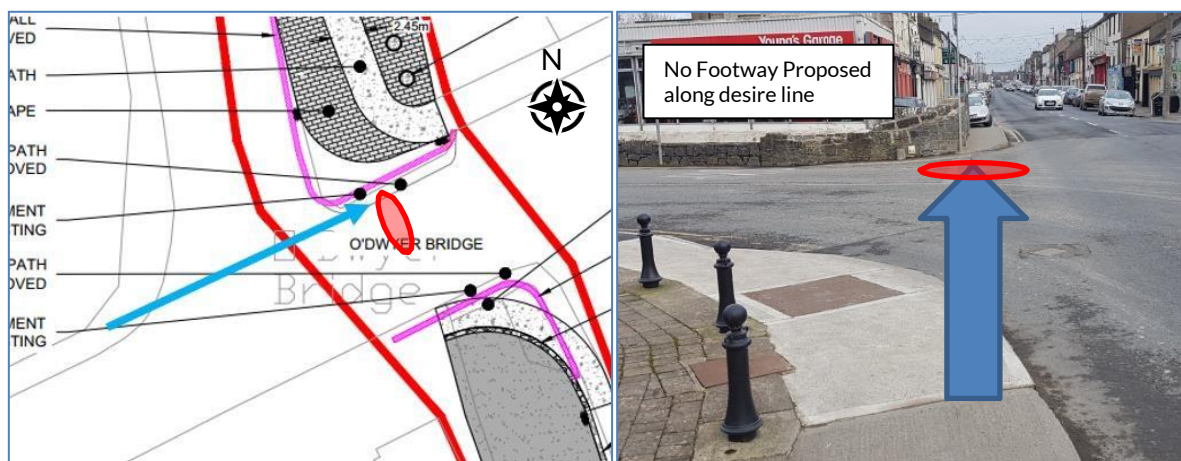
Figure 2-2 Existing Pedestrian Desire Lines across Blackcastle Road

At the streetscape area at the junction of Blackcastle Road and the N62, the roadway at O'Dwyer's's Bridge is proposed to be widened and the footway set back behind the existing parapet line. The Audit Team are concerned this will affect the pedestrian desire lines crossing Blackcastle Road. In particular, the existing infrastructure (i.e. drop kerbs) on the left hand side of the junction will guide visually impaired VRUs into the road carriageway, potentially leading pedestrians stranded in the carriageway and collisions between motorised and pedestrians.

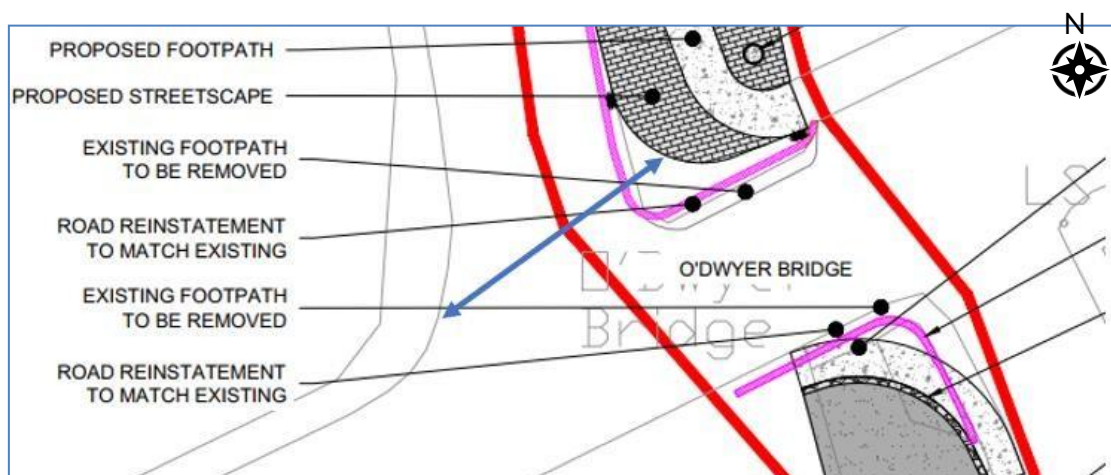
Figure 2-3 Proposed N62 / Blackcastle Road Junction Width

The proposed design shows work only to the eastern side of the N62 / Blackcastle Road junction. The existing wide corner radius on the west side of the junction, in conjunction with the increased eastern corner radius will potentially give rise to higher vehicle speeds turning at the junction. It will also result in increased pedestrian crossing times, which will increase the risk of collisions between motorised and non-motorised road users.

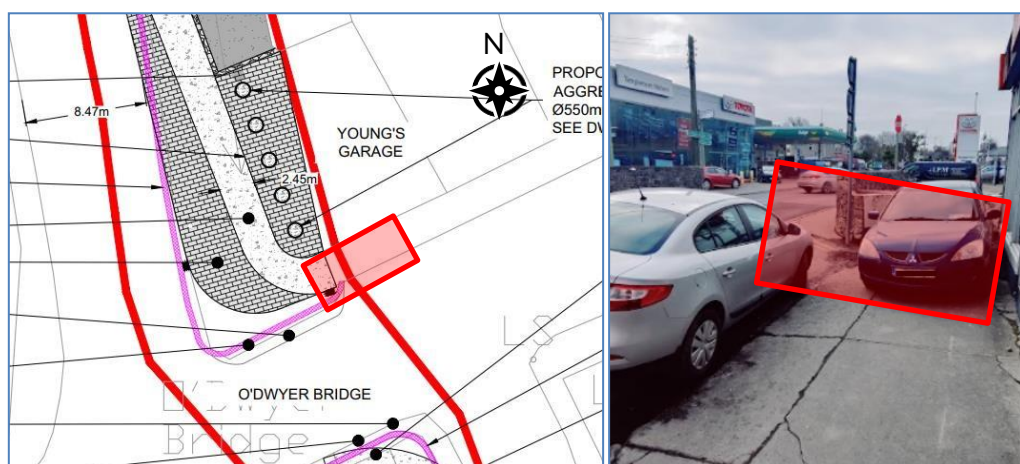
Figure 2-4 Interface of proposed footway and existing footway alignment

The Audit Team observed parking to the east of the N62 / Blackcastle Road junction fronting Young's Garage. The proposed footway alignment tying into the existing footway, may overlap with this area, displacing vehicles resulting in vehicles parked in closer proximity to the junction negatively impacting on visibility. Or vehicles parked on the proposed footway impeding pedestrians.

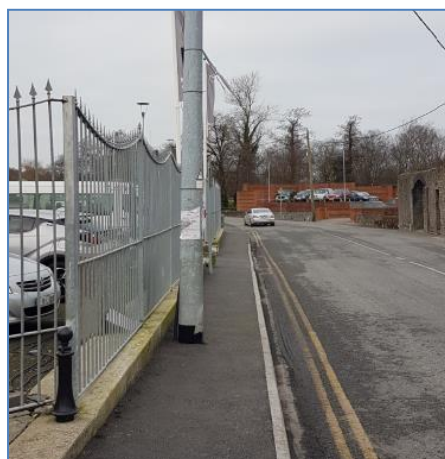
Figure 2-5 Restricted Footway Width on Blackcastle Road adjacent to scheme

The Audit Team noted during the site visit that adjacent to the scheme are areas of restricted footpath widths due to temporary and permanent fixtures.

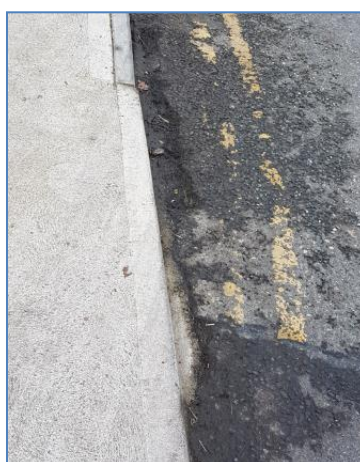
Figure 2-6 Trip hazards at drop kerb locations

The Audit Team noted during the site visit that adjacent to the scheme drop kerbs which exceed the allowable specification tolerances and deterioration of the road pavement are creating trip hazards for pedestrians.

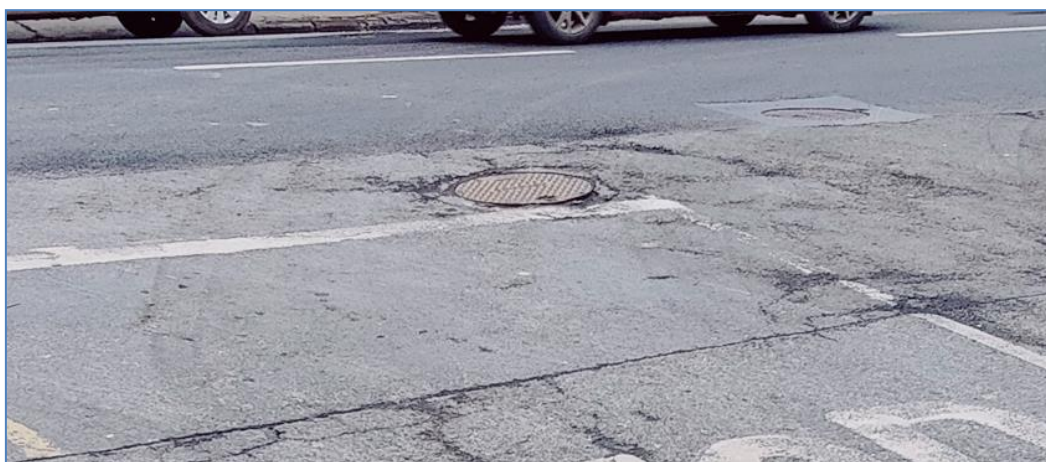
Figure 2-7 Pavement Deterioration at Utility Covers

The Road Safety Audit Team observed during the site visit that pavement deterioration was occurring at some utility covers potentially creating an issue for vehicles and trip hazard for pedestrians.

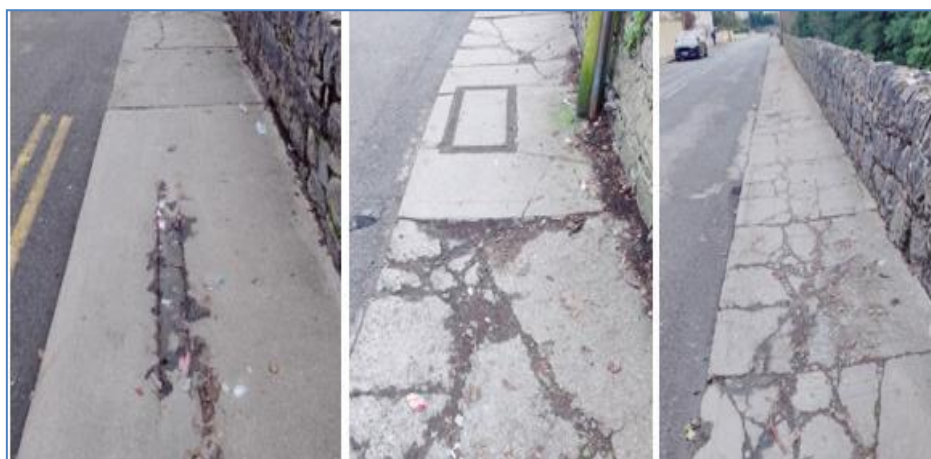
Figure 2-8 Examples of Footway Deterioration adjacent to proposed works

The Road Safety Audit Team observed during the site visit, significant pavement deterioration on the River Mall Road creating a significant safety and trip hazards for pedestrians.
