Nenagh Historic & Cultural Quarter, Castle & Prison

Volume 1: Conservation Report - Architectural Inventory & Appraisal

Date: November 2023

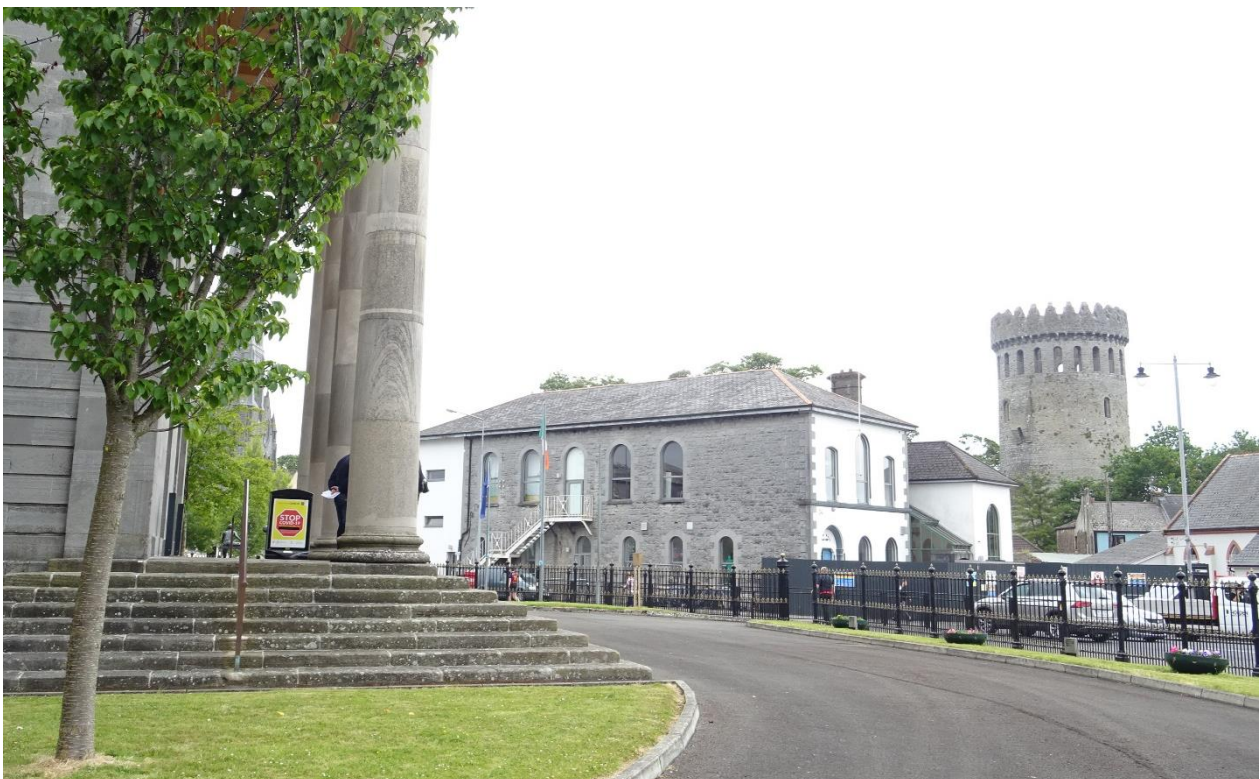
Fig. 24: Similar view as above, taken 2021. Views to castle, Presbyterian church and Townhall remain largely unobstructed. Boundary railings to courthouse and majority of Townhall intact. © Carrig.

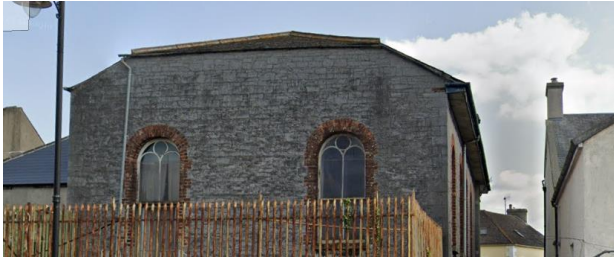
Fig. 32: The rear of the property looking south on O’Rahilly Street to Castle Street are an asset to the historic character but require maintenance. © Google Streetview.

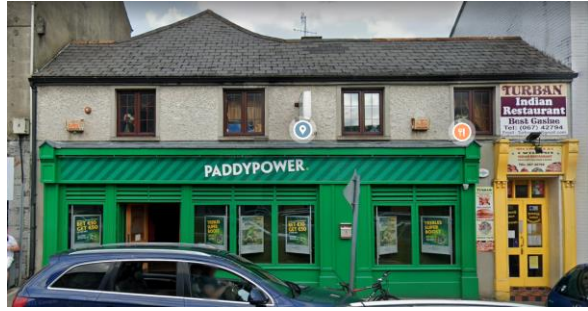
Fig. 37: Well-preserved traditional timber shop front, Kickham Street. The monotone colour scheme and branding and additional signage however, detracts from the historical features. The property has numerous modern interventions which has eroded its character above street level.

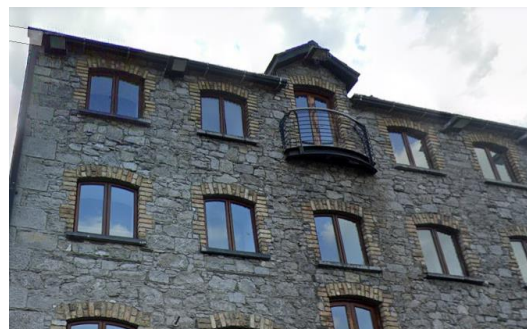
Fig. 39: While the finish likely would have been lime plaster, the exposed stone with brick surrounds offers a please texture and tones to the townscape.

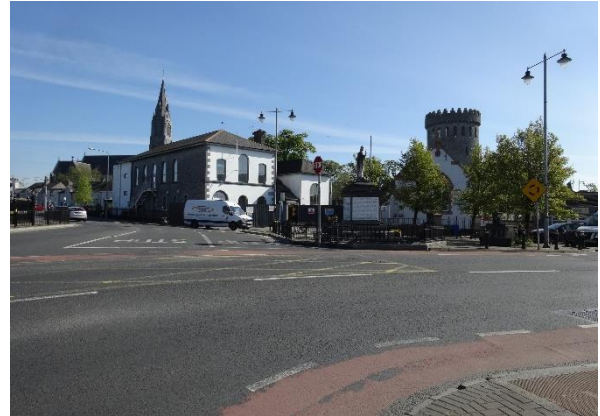
The single type of modern paving to Banba square does not have a positive contribution to the space. Standard materials have been used to finish the streets and opportunity has been missed to differentiate and define the space through minor changes in surface treatments such as the use of paint colour and variety of material finishes.

Fig. 45: A view of Banba Square road surface, looking towards the castle and town hall.

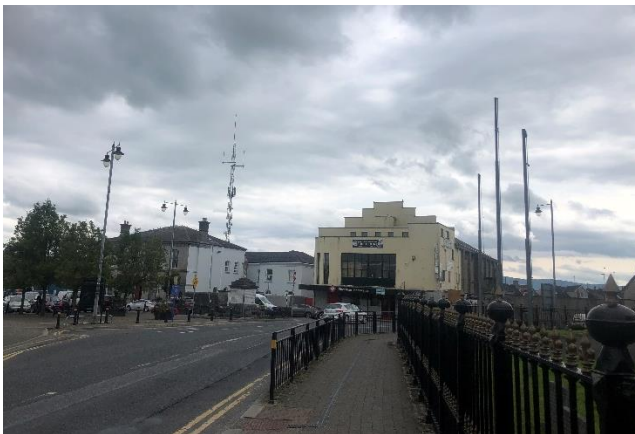
Fig. 46: Railings, bolards, ariels and flag poles are prevalent in Banba Square

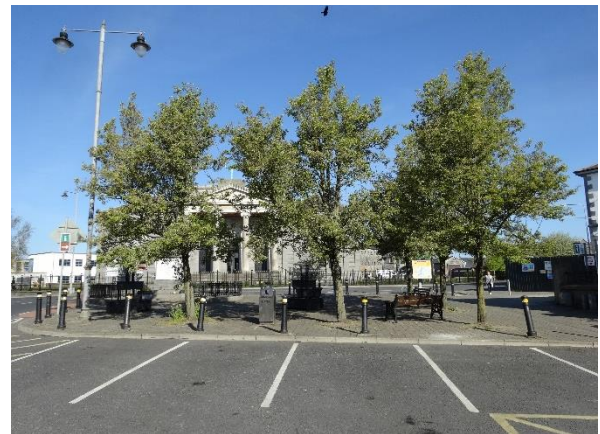
Fig. 47: Banba Square: view to the courthouse is blocked by trees.

Planting – planting of trees and planters can soften, add colour and texture and area while providing ecological habitat and shade. Locations and species of proposed new trees should be carefully chosen so as to not cause future issues to existing properties or obstruct views. Where existing trees obstruct views, it may be that in time, once they grow taller, the views may be rediscovered. Therefore, it is not considered necessary to remove existing trees for this reason.

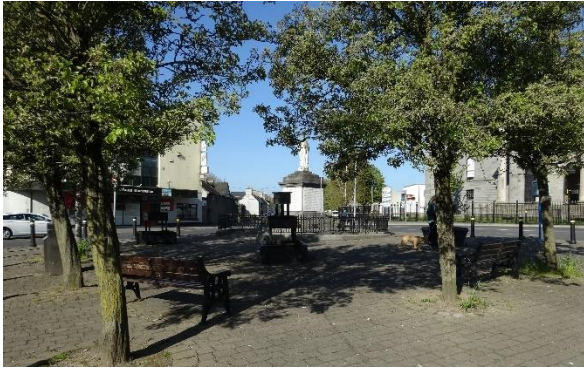
Fig. 48: Benches, bins and planters in Banba Square. These have been replaced since this image was taken and a common use of the cobalt blue from the bin in Fig. 49 has been incorporated into the arms and legs of the new benches.

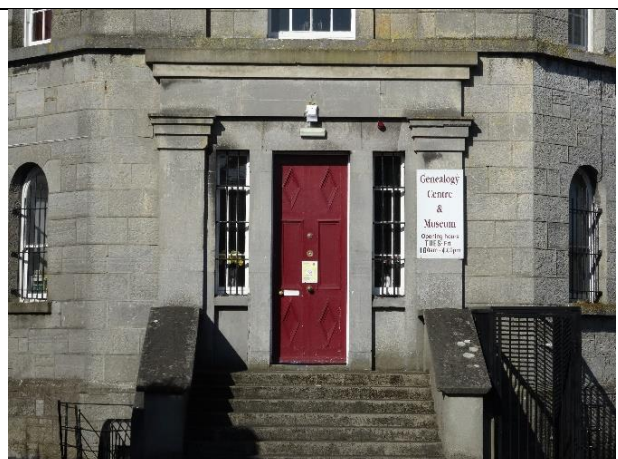
Fig. 61: Ashlar doorcase with pilasters and entablature, barred sidelights. Diamond and rectangular flat panels to painted timber door.

2. Localised piece-in stone repair to vertical stone jamb on left side of entrance door surround.
3. Localised piece in stone repair to 3 x locations on west elevation to S.E. specification.

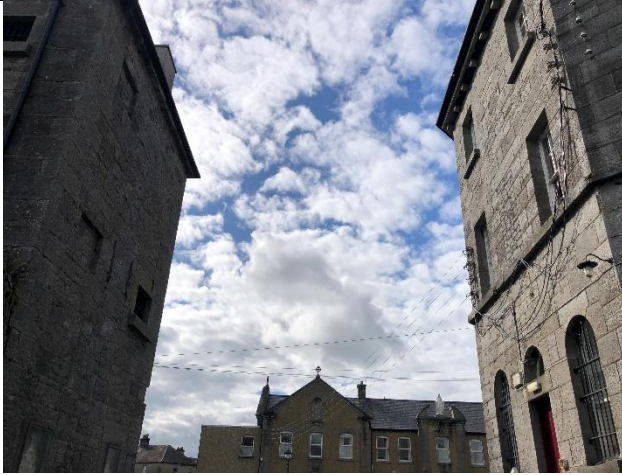
Fig. 66: View of space between governor's building and gaol block where there was historically gantry access.

4. Clean organic growth from all stone sills.
5. 3 x repairs to stone window sills to SE specifications.
6. Opening up of one blocked-up door on south elevation at L01 to proposed reinstated gantry. (Details TBC with Architects. Finishing, detailing and new door to be presented to conservation consultant for comment. Any repairs to door surround to use matching stone and lime mortar).

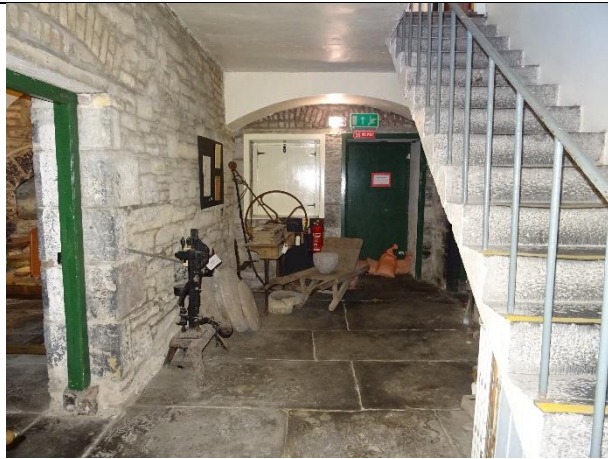
Fig. 70: Cantilevered stone staircase rising from basement to entrance hall.

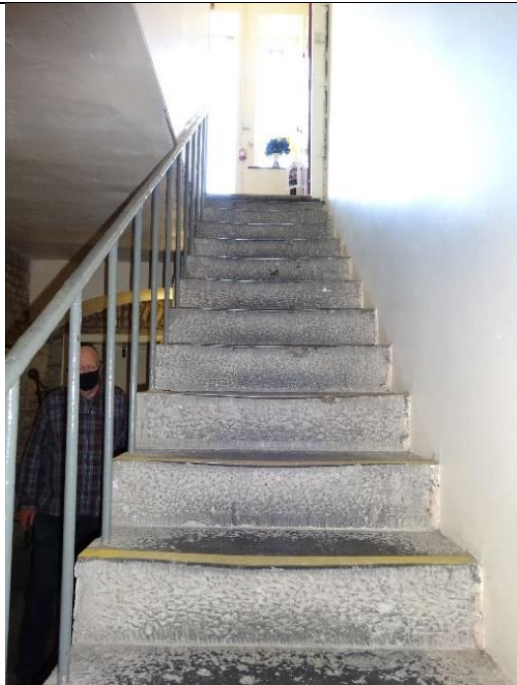
Fig. 78: Cantilevered stone staircase rising from basement.

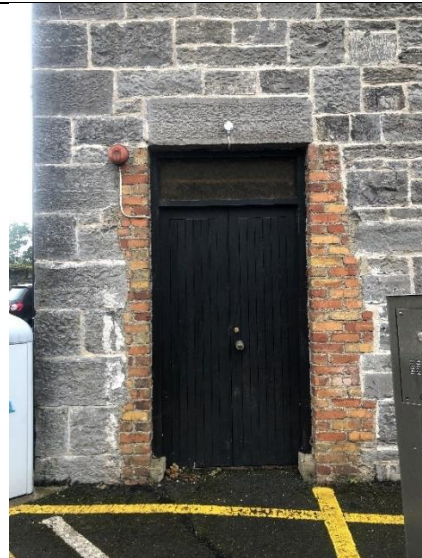
Fig. 103: Adapted door on south elevation of block, new brick piers are not supporting original opening lintel stone.

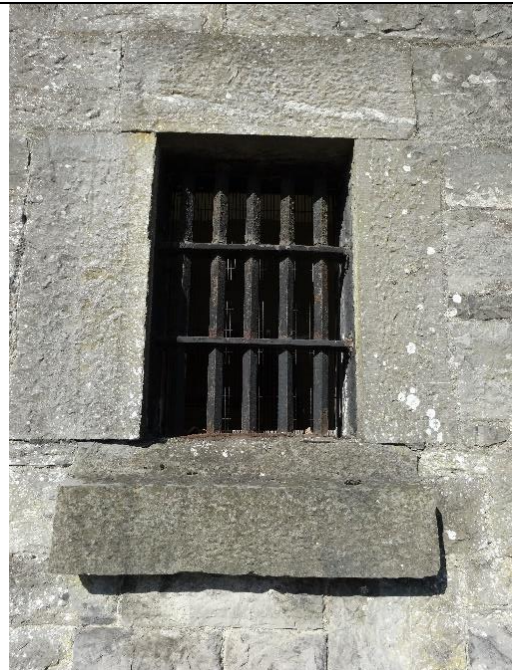
Fig. 109: Wrought-iron bars guard the narrow window of the cell block.

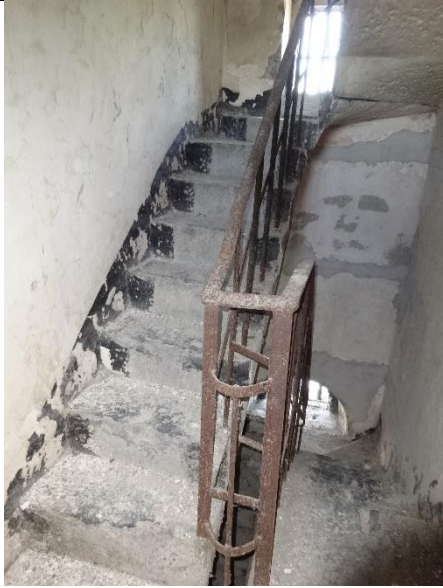
Fig. 113: Cantilevered stone stairs with wrought-iron balusters and handrails.

Except for these alterations, the cells and circulation areas have been largely unchanged since they were last used for prisoners, with original decoration scheme and historic markings from prisoners still visible on the upper floors. Stone elements have been removed in some areas and the cantilevered stair is showing signs of structural failure.

9. Provide new emergency lighting system to same specification as above.
10. Carry out structural repairs to cantilevered staircase to SE Specification.

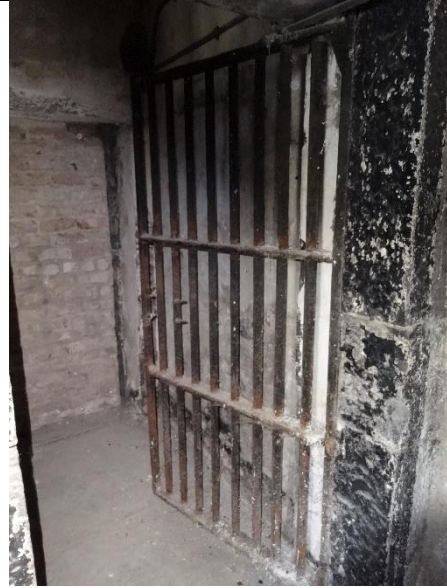
Fig. 114: Wrought-iron gate.

1. Remove rust to interior wrought and cast-iron features and rust treat & redecorate. (handrails, balustrades, gates, doors, hardware, window bars)
2. Refurbish and redecorate 8 x original metal windows.

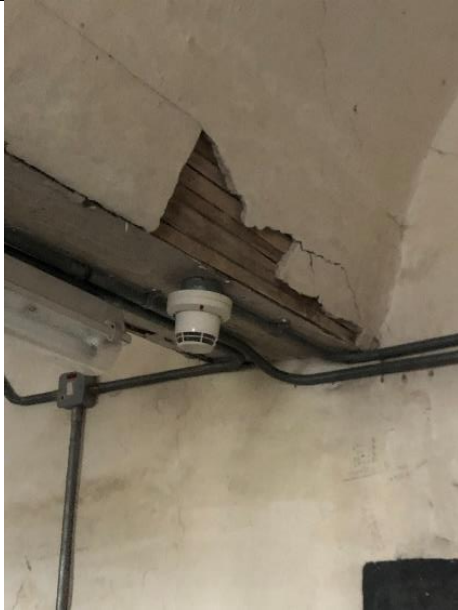
Fig. 115: Original barell vaulted lath and plaster ceiling in cell with modern surface fixed services.

1. Remove boast lath and plaster finish to all barrel-vaulted cells on FF and SF and carryout localised plaster repairs using lime. Specialist advice required to address the lath spacing and debonding of lime – extensive / complete repair may be required this must be confirmed by further investigation.

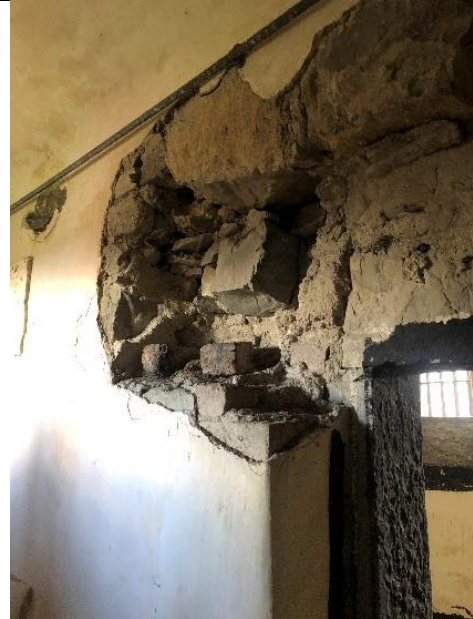
Fig. 116: A number of original stone door lintels have been removed from the upper floors.

Missing internal structural elements such as door lintels, jambs and missing sections of masonry will be replaced or rebuilt using like-for-like materials and repairs to flagstone floors, keystone arches and cantilevered stairs will be undertaken to the Structural Engineers specification.

3. Replace or repair missing or damaged structural elements including door lintels, door jamb supports, masonry arch keystones, flagstones and openings in rubble masonry throughout using matching stone and lime mortar to SE specifications.

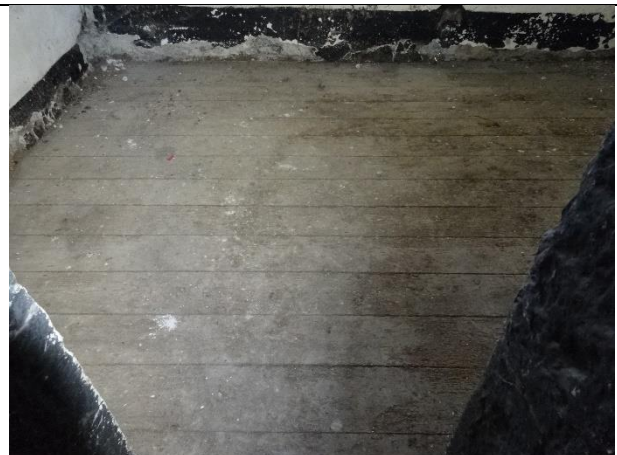
Fig. 118: Floorboards within a cell.

5. Carry out repairs to historic floorboards using matching timber sections where required. Allow for 5sqm.
6. Provide new surface mounted interior lighting system to support gallery / museum function. Cable ducts to be 'industrial' style metal finish and to use existing services routes insofar as possible. Lighting layout, design and specification TBC by STW.

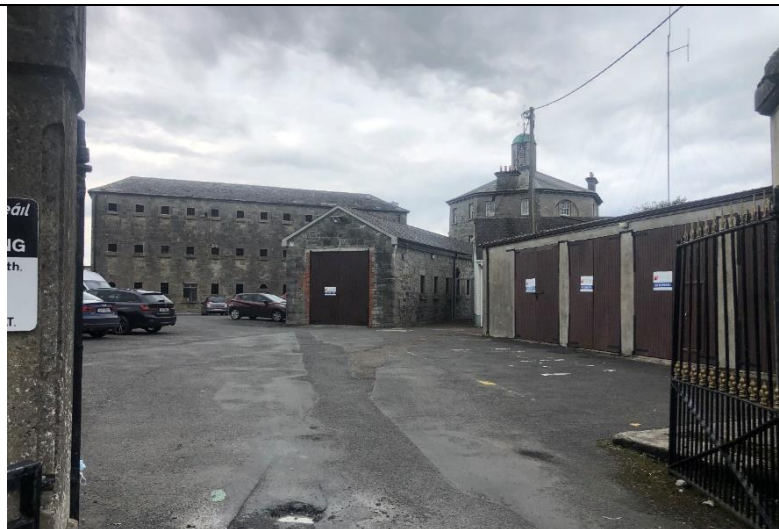
Fig. 121: View looking towards single storey cell block with modern shed structure visible to the right of the image.

[Note: shed structure is Building 1 proposed for demolition].

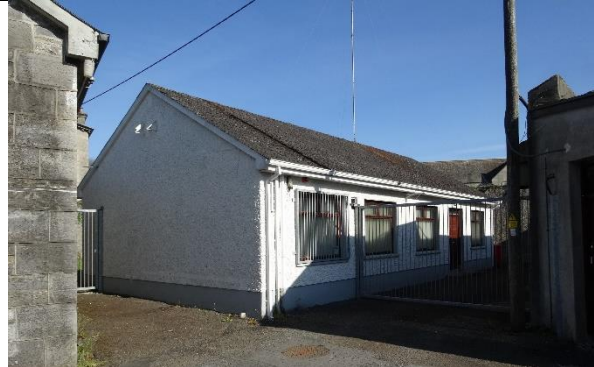
Fig. 123: Later 20th century office building within yard
[Note: white rendered Building 2 proposed for demolition]

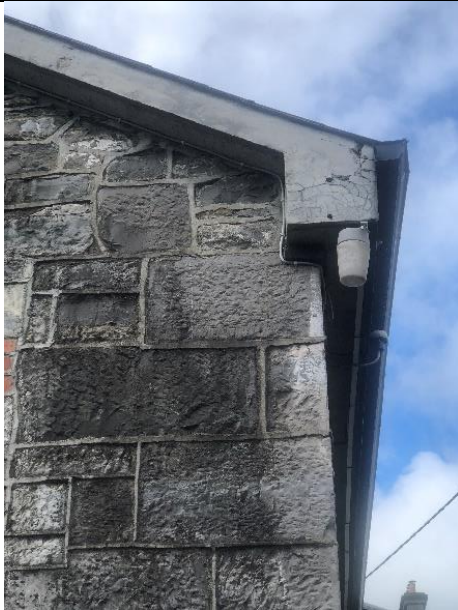
Fig. 124: View of concrete barge cast onto existing building

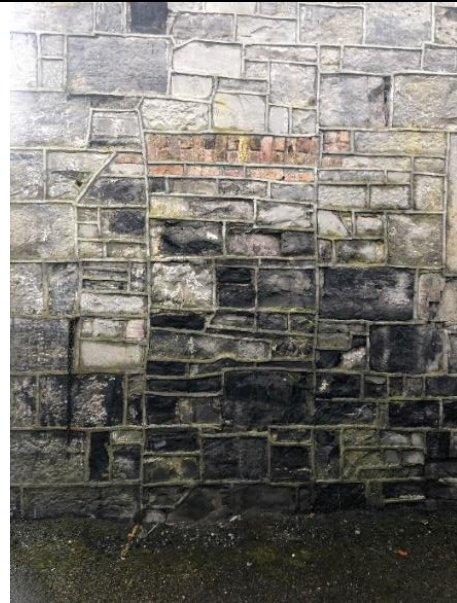
Fig. 125: Cementitious strap pointing and blocked up opening

A number of original stone elements to openings require repair or replacement. It has been fully repointed with cementitious strap pointing which is accelerating the delamination and spalling of the historic masonry.

NOTE: the thick cement-based strap pointing is harming the masonry and leading to delamination of sections of stone, resulting from freeze-thaw action. While it is not proposed as part of this phase of works, we recommend that this pointing is carefully raked out and the joints re-pointed using a lime-based mortar in the near future.

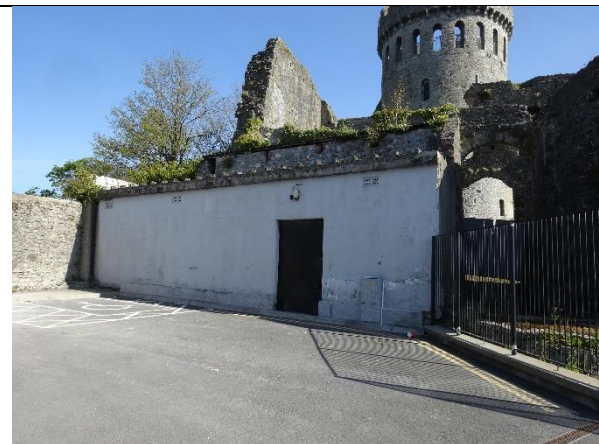
Fig. 159: The gate building is abutted by a single-storey building [proposed for demolition].

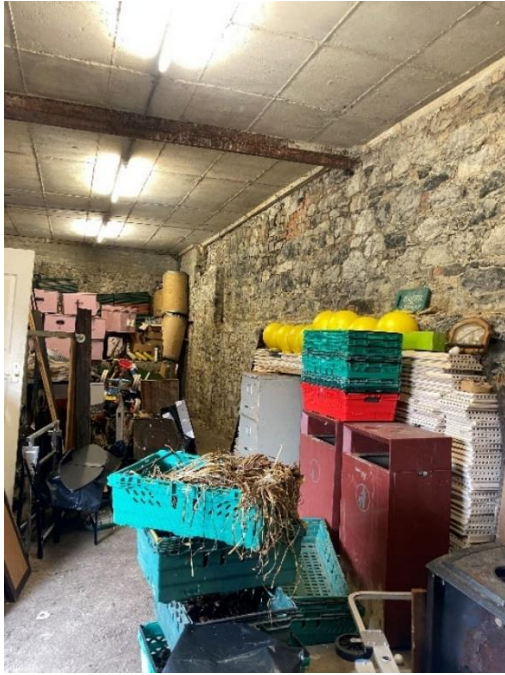
Fig. 160: Rear wall of Castle Shed viewed from the inside, note mix of historic masonry.

The historic masonry elements which are enclosed within this structure are in poor condition and have been repaired and infilled in a piecemeal fashion using inappropriate materials.

Castle Shed: It is recommended that the later inappropriate additions are carefully removed to expose the historic masonry elements on the north, east and west walls, as well as the low internal wall. Historic masonry should be carefully surveyed and recorded. Masonry to be raked and re-pointed using lime-based mortars. The conserved masonry elements will enhance the setting of the carpark adjacent to the castle.

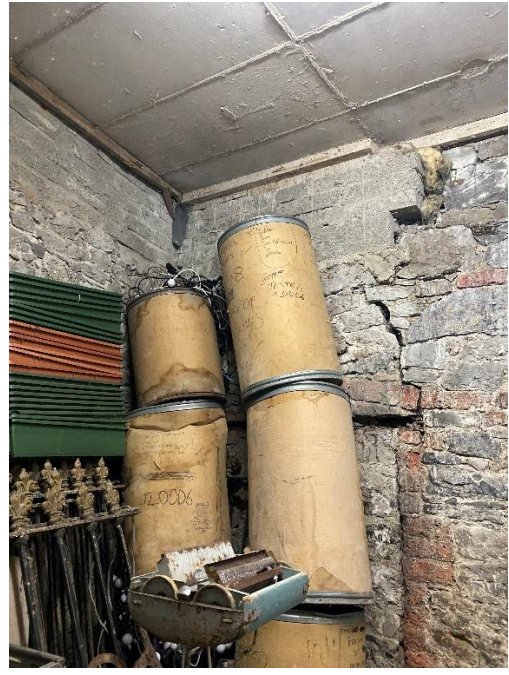
Fig. 161: Northwest corner of castle shed walls from the inside, note red brick opening reveal.

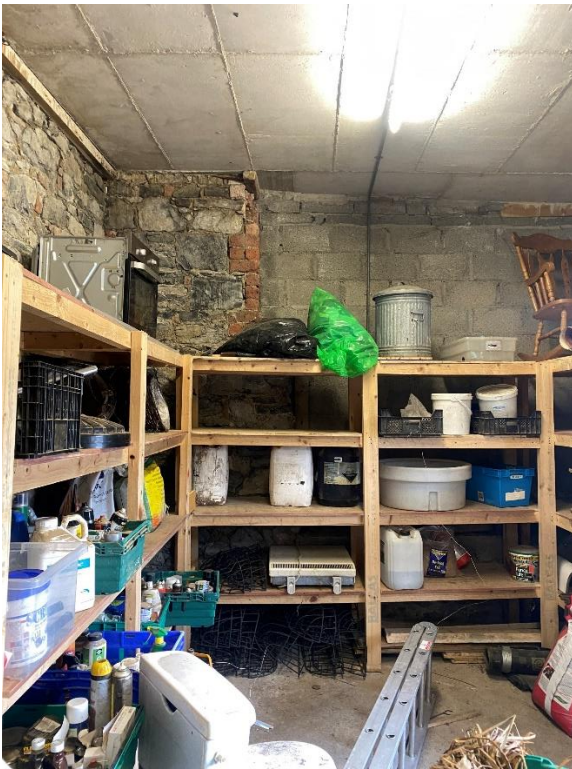
Fig. 162: North east corner of castle shed viewed from inside, note red brick masonry quoin detailing.

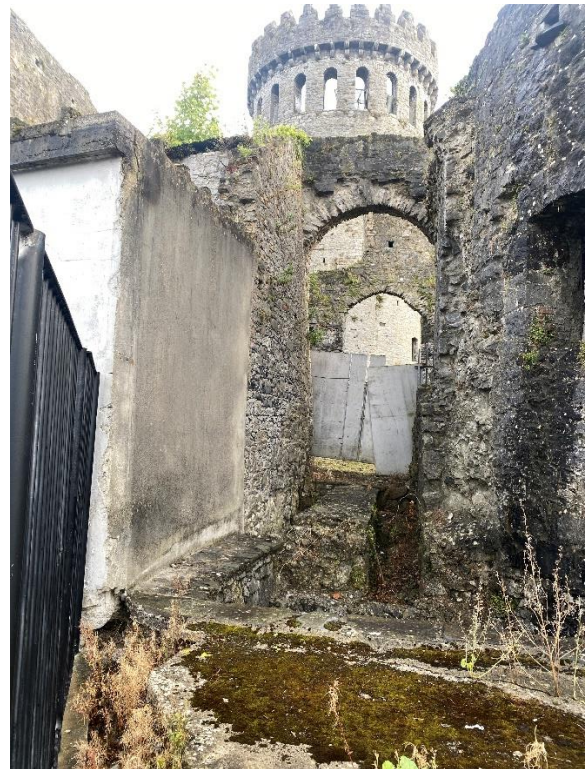
Fig. 163: View of same wall from exterior where it abuts the castle gatehouse structure.

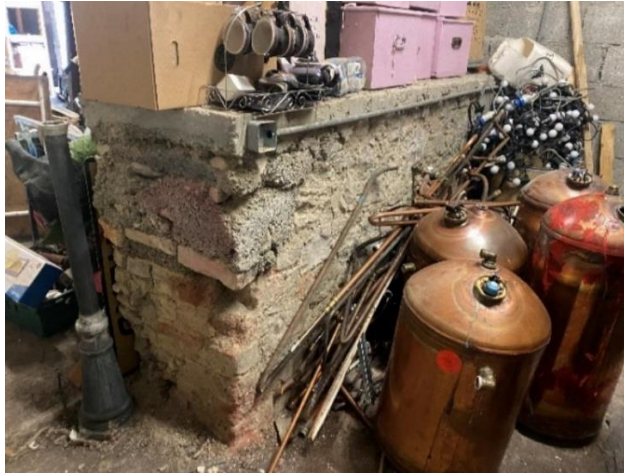
Fig. 164: Low section of masonry walling located within the castle shed.
